Development of Landslide Risk Assessment Technology along Transport Arteries in Vietnam

Proceedings of the Final SATREPS Workshop on Landslides

13 October 2016, Hanoi, Vietnam

Published by
Institute of Transport Science and Technology (ITST)
International Consortium on Landslides (ICL)

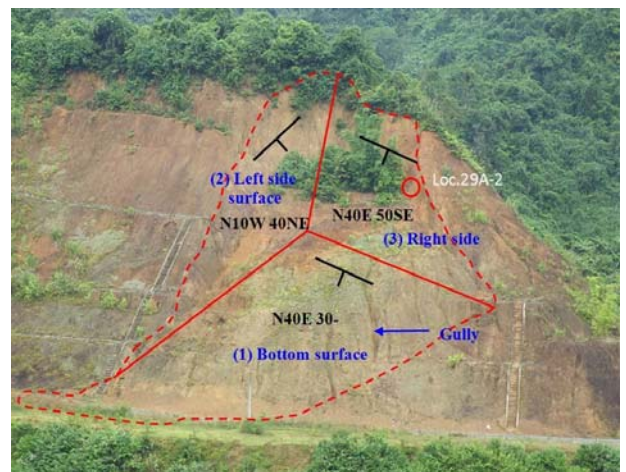
Fig. 13. Landslide No.029 on HCM route

The combination works of contour from W3D data, field investigation, soil testing and simulation lead us the presence of real phenomenon and will suggests the alternative countermeasure strategy setting. Fig. 13 and Fig.14 is a sample of investigation. Fig. 13 is the small landslide occurred in rainy season 2009. It looks one block wedge type slump. Based on the detail investigation, the slip structure is composed by three small slip surfaces.

The two steep surfaces follow the geological structures. The bottom surface stretches to a part of road. Soil strength mentions in table 1. Fig. 14 is the result of simulation of RBSM_{3D} analysis. According the trial calculation, SF value changes from 1.2 to 0.92 according with the increase the ground water level.

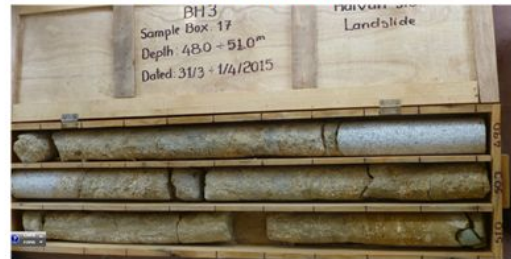
Drained Speed Control Test

1. The sample was fully saturated
2. Consolidation to close to:
 - ❖ 780 kPa
3. Shear at 0.2 cm/s in the drained condition.
4. After the shear surface reached peak shear resistance, the drained normal stress was reduced to zero at a rate of $\Delta\sigma=5$ kPa/s
5. The peak friction angle and friction angle during motion remained = 39.0° .

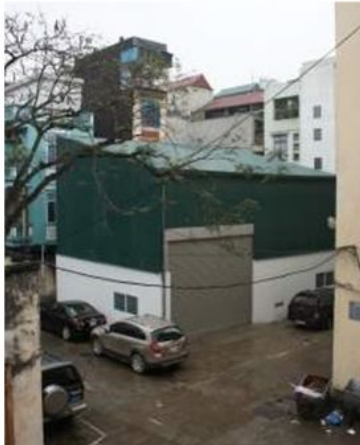
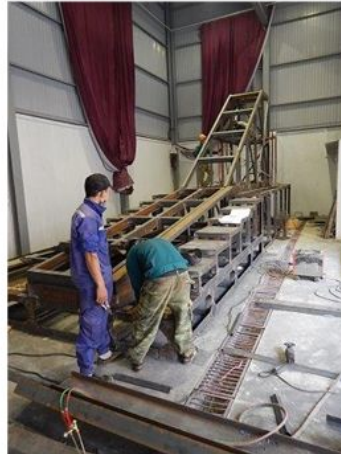
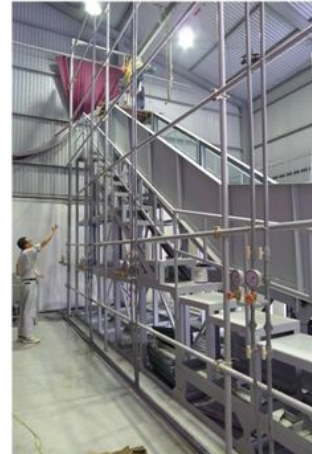
Landslide flume

In 2013, landslide experimental facility was designed and the building was made. In 2014, the data logging system and sensors are donated. The landslide flume was designed based on the soil properties of the weathered granite of Hai Van area. In 2015, the landslide flume with rainfall simulator was constructed and first landslide experiment in Vietnam was conducted in ITST in November 2015.

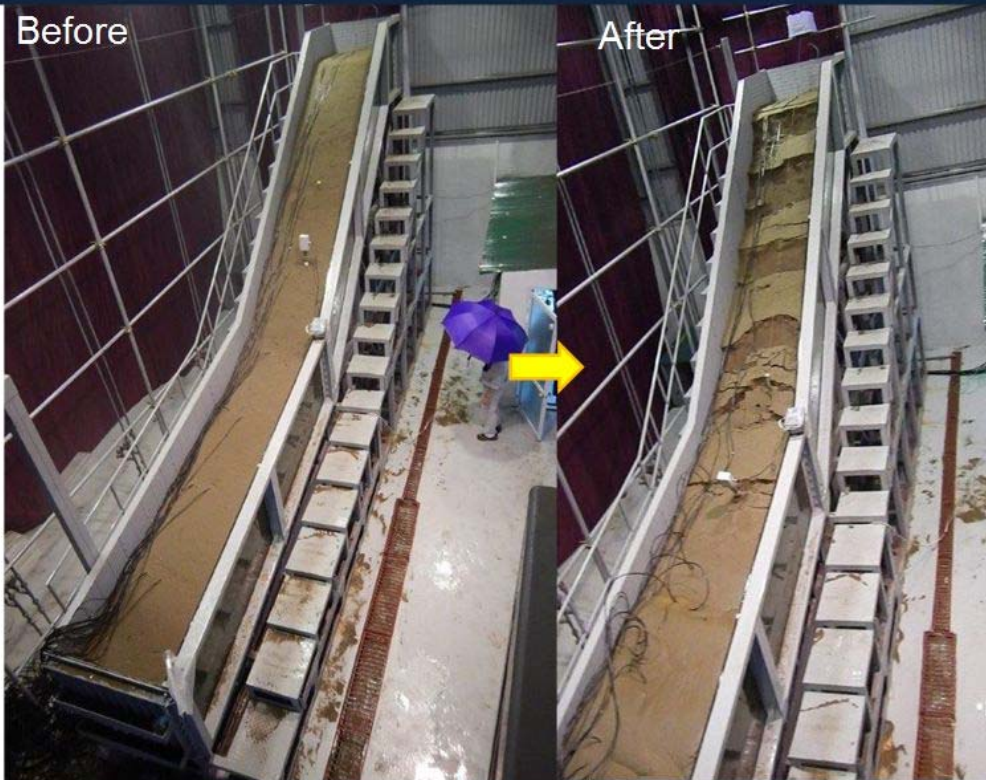
Landslide occurrence on flume

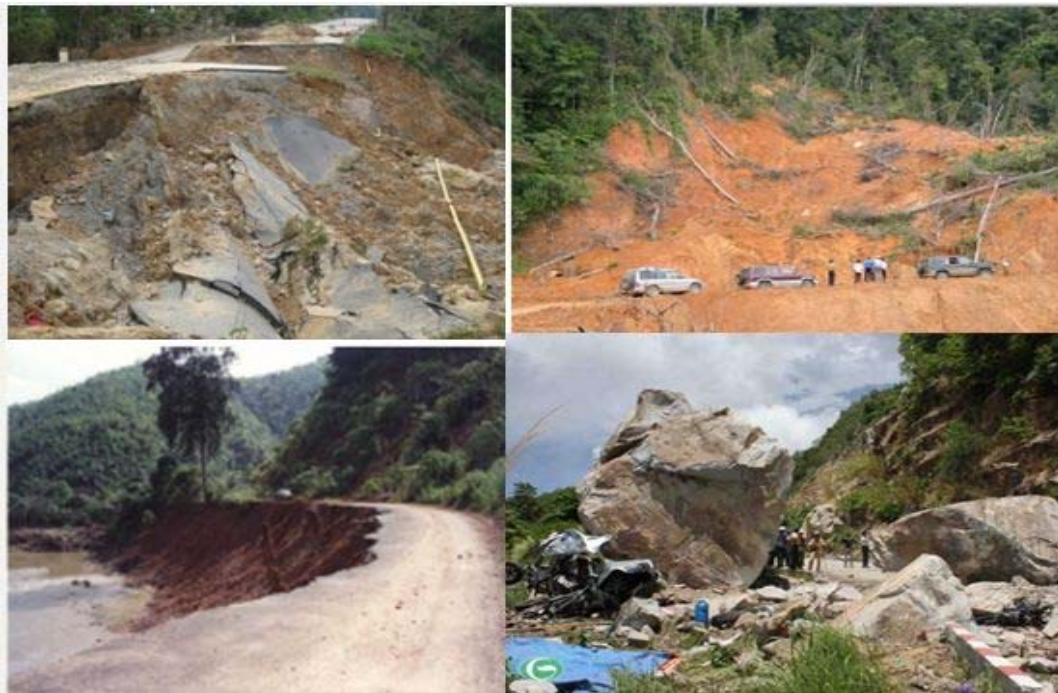
Fig 2. Some pictures of landslide taken in project area

Damage caused by landslides are summarized primarily by objective reasons, such as intense rainfall concentrated in a short period in areas with steep slopes, sensitive geology structural. Beside this, in many cases landslides occurrence have main distributed cause by human economic developing activities that lacks of knowledge of disasters.

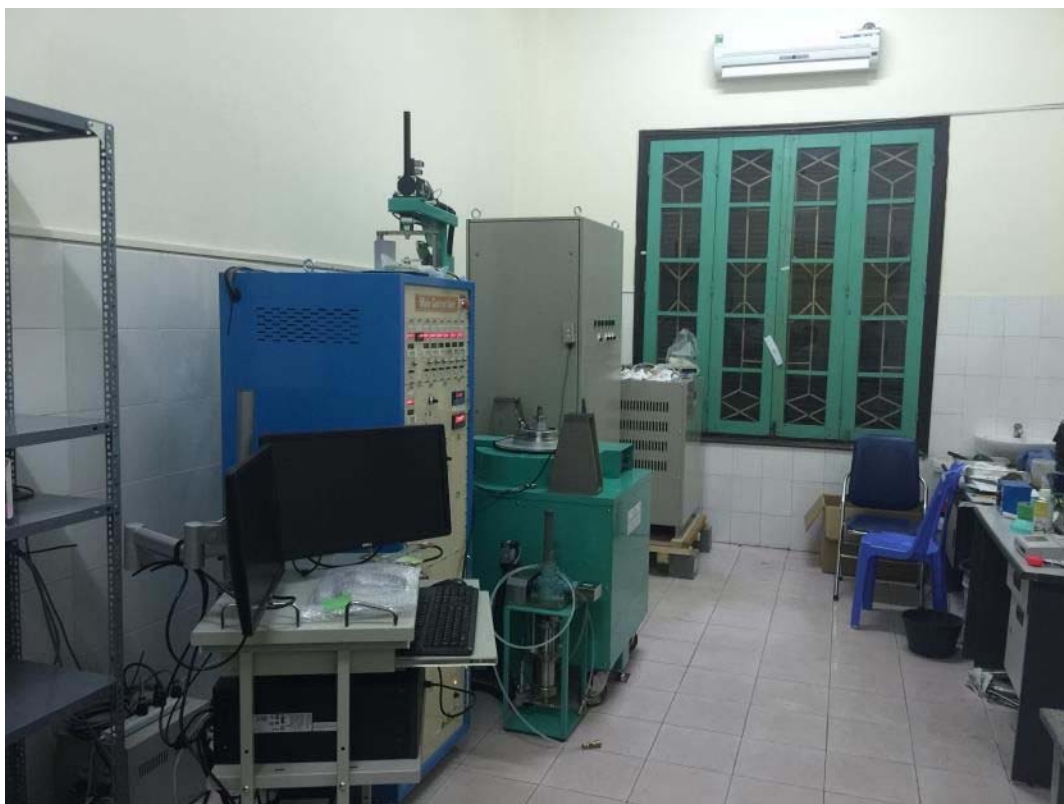
Fig 7. Pictures of a high-stress undrained dynamic loading ring shear apparatus (ICL-2) in Lab. ITST, Vietnam

Testing group developed a high-stress undrained dynamic loading ring shear apparatus (ICL-2) which can be applied to deep landslides more than 100m. Pictures of a high-stress undrained dynamic loading ring shear apparatus (ICL-2) in Lab. ITST, Vietnam is presented in fig 7. The development and its first application to the Unzen Mayuyama Landslide killed 15,000 people in Japan

was reported in Landslides (Impact factor 3.049) Vol.11, No.5 in 2014. The methodology and testing from this apparatus is useful for understanding the landslide moving mechanism, especially to depth seat one. For Vietnamese research and scientist field, it is also considered the newest one. The developed ring shear apparatus was revised in 2014-2015 based on the experiences of testing by Vietnamese short-term trainees as well as long-term trainees. Major revision was to add new two safety systems to protect the apparatus from miss-handling by testing persons. The revised apparatus was installed in ITST in June 2015 and now it is available for testing. (Lam.H.Q, project report 2016).

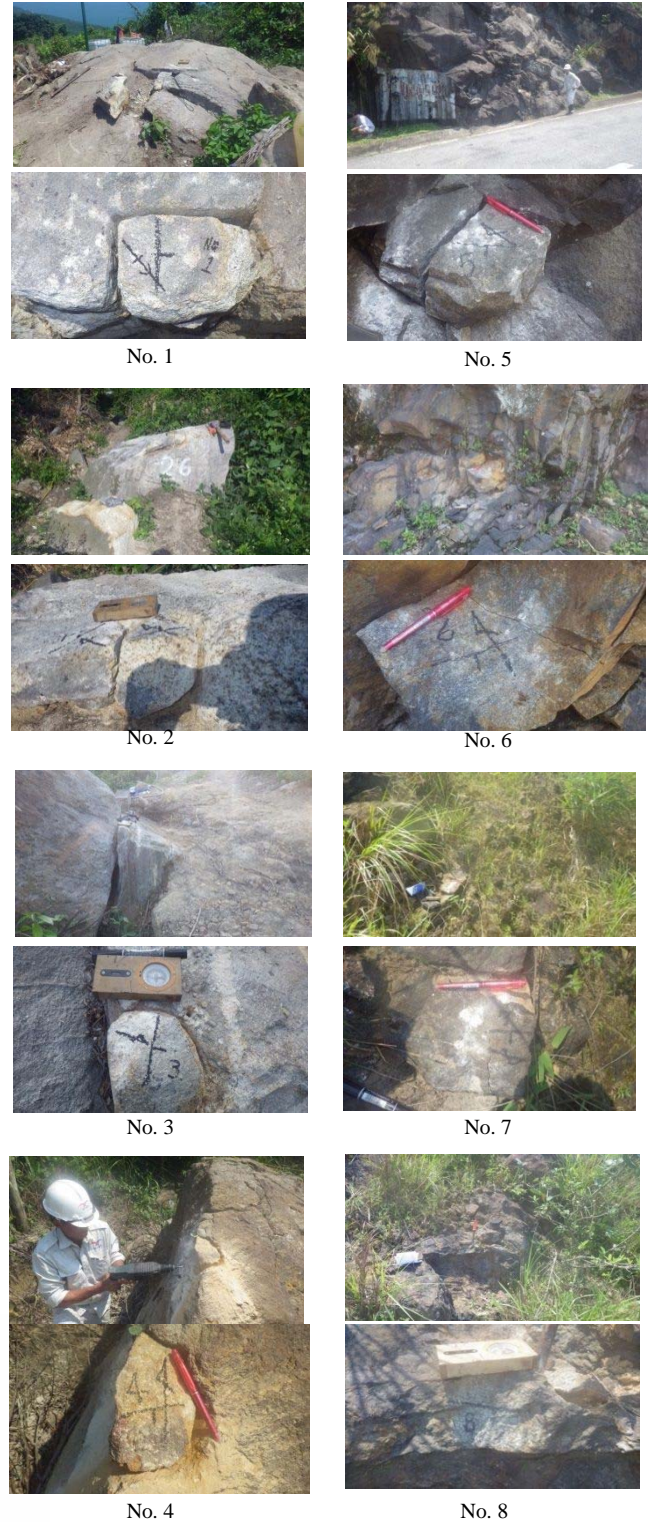
Fig. 8 Sampling of remanent magnetism measurement specimens from exposures

Studies of remanent magnetism have strongly affected the field of earth science from geomagnetic reversal and polar wandering from the early 1960s to the elucidation of plate tectonics (Holmes, 1978; Konno, 2009). Recent studies of diverse disciplines include examinations of the global environment (Sakai et al., 2000), studies of age determination in archaeology (Hirooka et al., 1988), lava flow accompanying volcanic activity (Urrutia-Fucugauchi et al., 2004), and studies of mud-flow on hills because of debris avalanche (Mimura et al., 1982, 2003; Sakai et al., 2003). Remanent magnetism measurements were conducted for this study in specimens obtained from corestones scattered on the ground surface in the Hai Van landslide and drilling cores, and specimens from exposed base rocks outside the Hai Van landslide (Fig. 7). Then the experiences of past landslide movements were examined from the variation in magnetic direction. Rock fragments were collected using a rock hammer and a base rock twist drill to prepare specimens from the corestone and eight exposed base rocks outside the landslide (Fig. 8). The selected target corestones were too gigantic to have been moved by human power. Specimens obtained from drilling cores were six specimens from cylindrical cores taken from strongly weathered granitic rocks and four specimens from fresh base rocks (Fig. 9(d)). A core of a diameter of about 3 cm was gouged out of a rock fragment fixed with concrete using a water-cooled engine twist drill with a diamond-bit (Natsuhara Giken Ltd.). Then the gouged piece was shaped to a height of 1.5–2.5 cm for magnetic measurements using a rock cutter (Fig. 9).

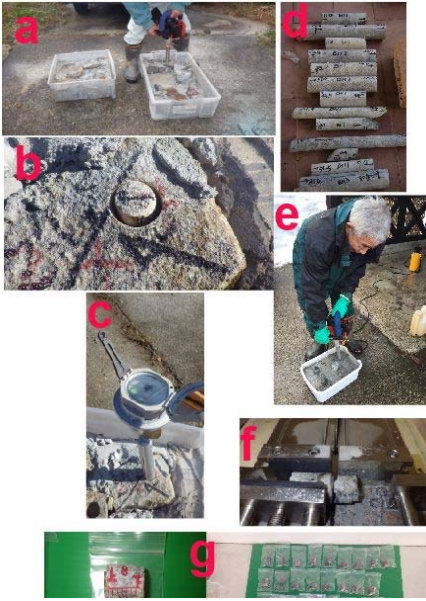
Fig. 9 Sampling and shaping of remanent magnetism measurement specimens: a, b, c, specimen gouging from exposed rock fragments; d, e, drilling core samples and specimen gouging; and f, g: shaping and completed specimens.

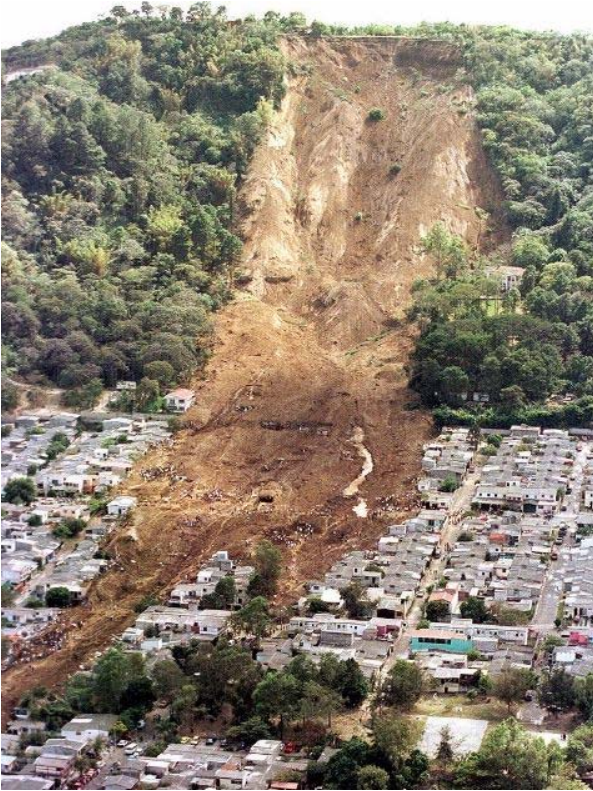
Fig. 1 Area view of earthquake-triggered landslide in Las Colinas, El Salvador, January 13, 2001 (Source: wikipedia.org)

Earthquake-induced landslides are among the most destructive phenomena related to failure of slopes during earthquakes (Trandafir 2006). Globally, many locations have over steepened and highly weathered hillsides, where large landslides could cause significant harm to local communities—many of which are already vulnerable in terms of housing structures and poverty. The 2001 earthquakes in El Salvador are a notable example in this regard, causing over 600 landslides and resulting in many hundreds of fatalities, with 585 deaths in the community of Las Colinas alone (Figure 1) (Anderson 2013).

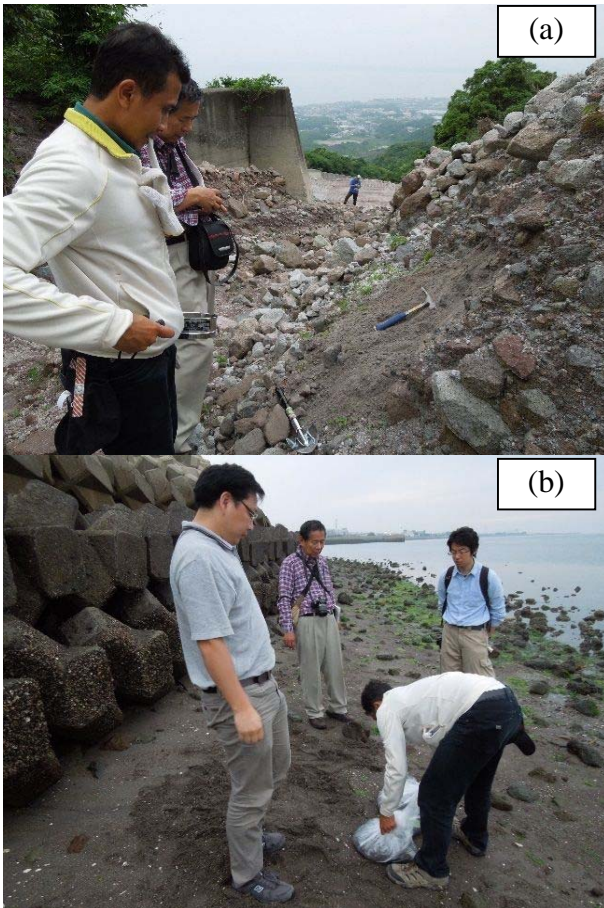
Fig. 4 Photos show the sampling locations: a) Sample Unzen-1 was taken from an exposed slope along the upstream of a check dam constructed in 2012-2013; b) Sample Unzen-2 was taken from the coastal area

During the investigation of Unzen-Mayuyama area for researching this historical megaslide, we chose two samples, one in the source area and one from the coastal area outside the landslide moving area. The location of sampling is shown in Figure 2 and the sample site is shown in Figure 4. Sample Unzen-1 was taken from a sand layer exposed along a torrent gully in the source area of the landslide. Sample Unzen-2 was taken from the coastal area outside the landslide area to represent the soil overridden by the landslide. The mountain consists of volcanic lava rock and unconsolidated eruption products (debris and sands). The sliding surface of the landslide probably formed within a sandy layer rather than in the strong intact lava rocks and boulders. We took samples from a sandy zone exposed along a torrent gully side slope in the source area. The grain-size distribution of the samples is shown in Figure 5 in which the Unzen-1 sample is finer than the Unzen-2 sample. The component of the sample 1 was 91% sand and 9% fine, while sample 2 was almost sandy particles.

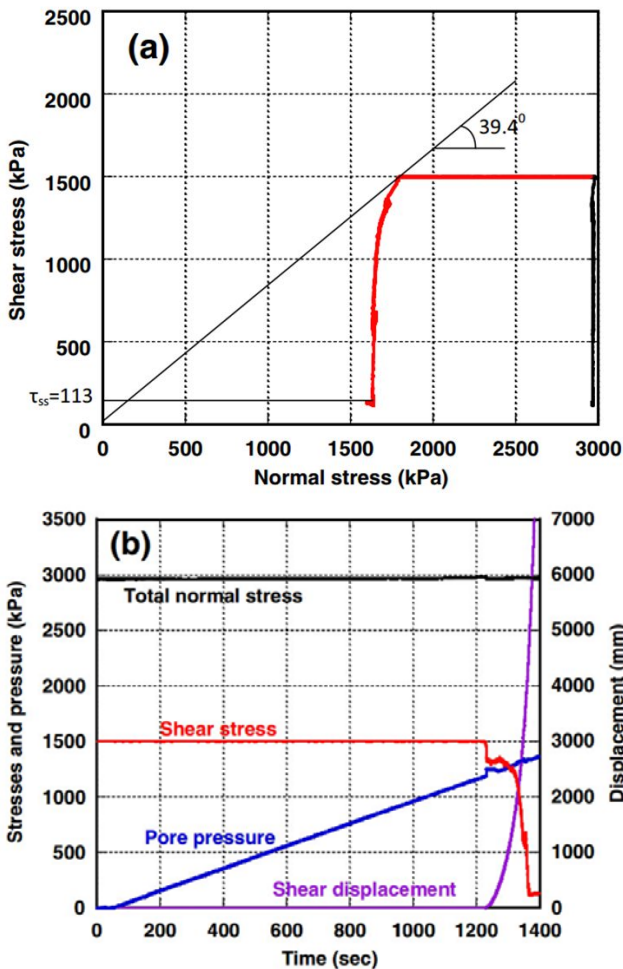
Fig 9 Pore pressure control test on sample 1. Sample: S₁ from Mayuyama source area. BD=0.98

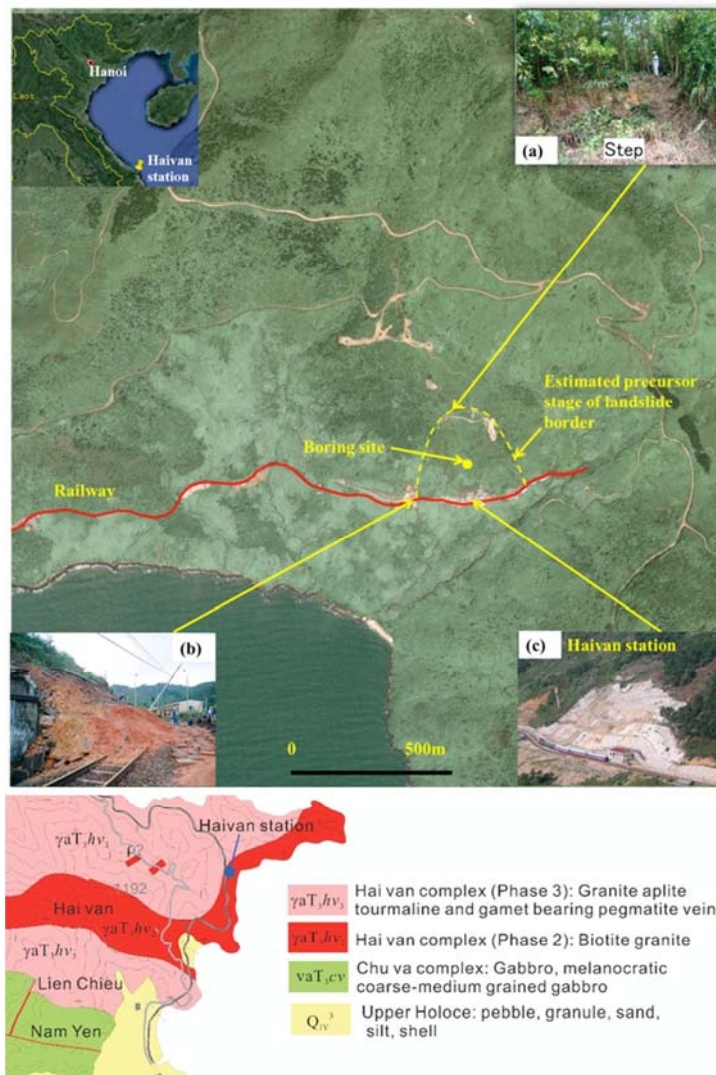
Fig 1. Location, topography, landslide border and geological structure of Hai Van station landslide, Danang city, Vietnam (a: a small step where a head scarp of a landslide may be formed; b: previous landslide in 2007; c: Hai Van station)

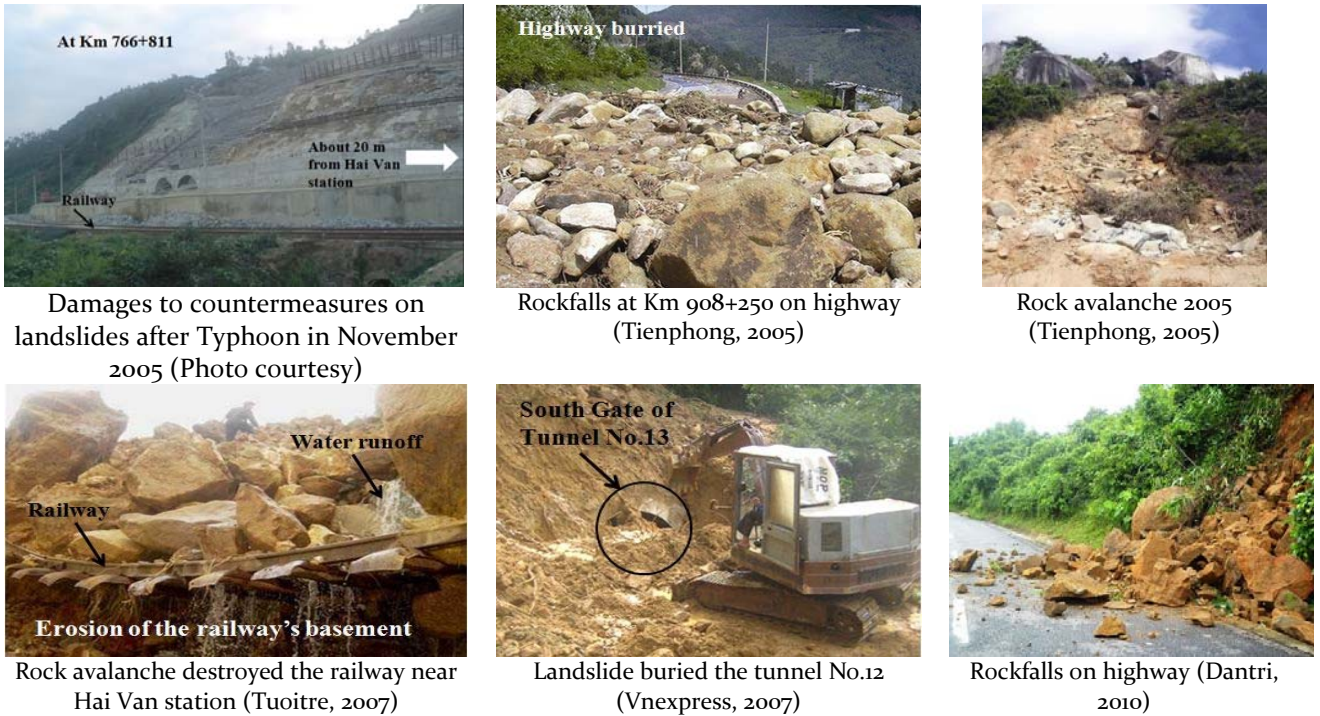
Figure 2 Photos of several landslides and its impacts

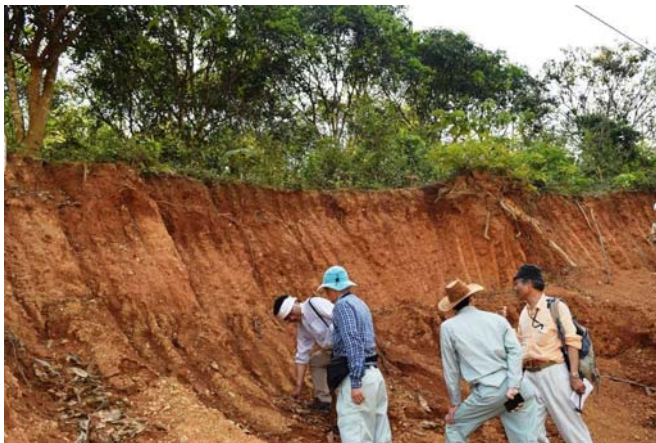
Fig. 1 Landslide field survey along the National Road No. 7 (May, 2016)

During field investigation, slip surface, geological features, geology and weathering, type of landslides along road have been discussed and clarified by Vietnamese engineers and Japanese experts (Fig.1, Fig. 3, Fig. 4).

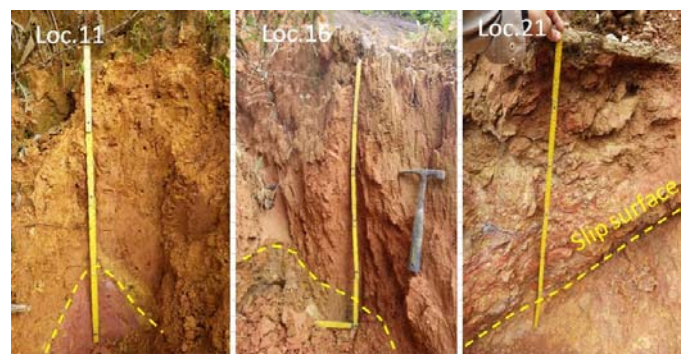
Fig. 4 Identify slip surface at the landslide site along Ho Chi Minh Road (Aug, 2013)

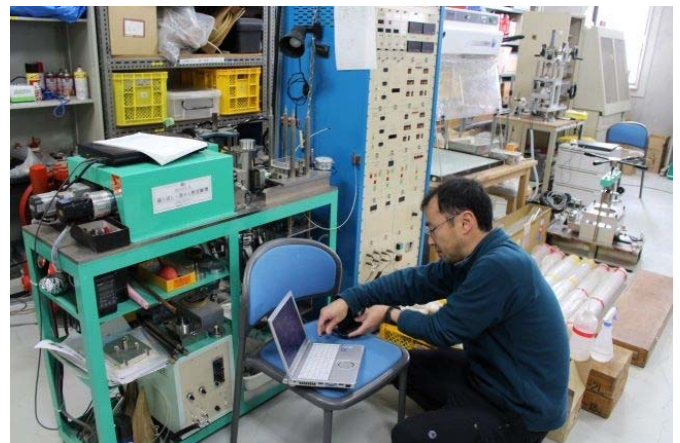
Fig. 8 Residual strength characteristics of weathered rocks were conducted in the laboratory in Fukushima, Japan (Dung et al., 2016 submitting).

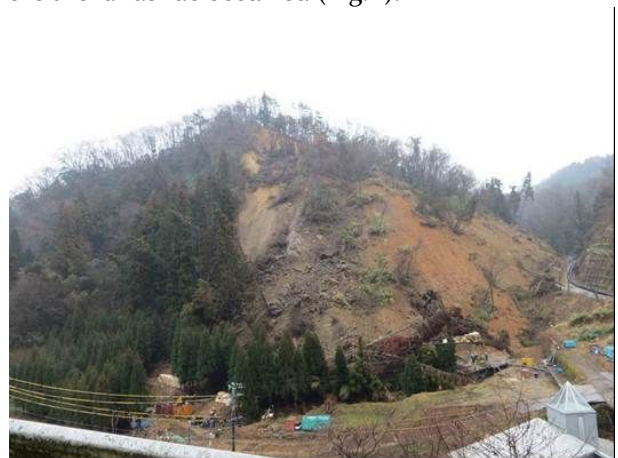
Figure 1 Side-view of the Mihata landslide (taken by Do N.H., 26 Nov. 2012)

Shimane Prefecture is located along the western coast of Shimane Prefecture is one of the three areas in Japan strongly affected by landslides. In the early morning of 6 August 2012, the Mihata landslide occurred in Izumo city, Shimane Prefecture, Japan. The landslide was not triggered by obvious rainfall, nor by an earthquake. However, a high-precipitation event was recorded in the Sada district of Izumo city on 6 July 2012, one month before the landslide occurred (Fig. 1).

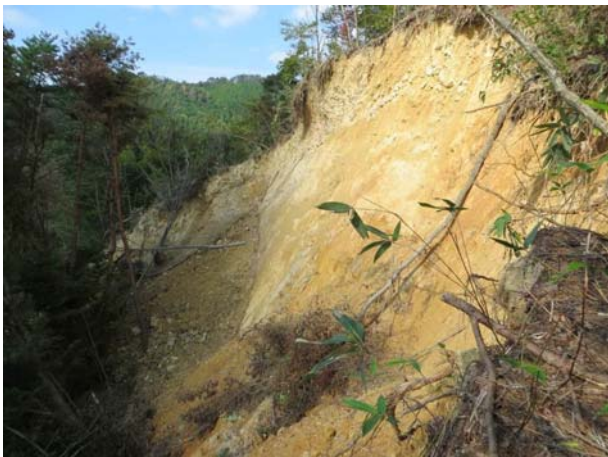
Figure 2 Main scarp of 20 m in height (taken by Do N.H., 15 Oct. 2012)

The Mihata landslide occurred in in the early morning of 6 August 2012. The landslide was not triggered by obvious rainfall, or by an earthquake. However, a high-precipitation event was recorded in the Sada district of Izumo city on 6 July 2012, exactly one month before the landslide. The maximum hourly precipitation recorded was 74 mm, with a 10-minute maximum of 21.5 mm. Although smaller than the Tsuwano and Gotsu events described above, this was also a 37-year record rainfall for Izumo city. Light rain fell for a few days after the main event, and all rainfall ceased on 21 July. At that time the Mihata slope did not show any obvious signs of deformation. On 26 July 2012, a small collapse occurred at the right end of the slope, near the Mihata River. A main scarp with a height of 3 m was detected in the Mihata landslide on 2 August 2012. A large and sudden deformation then occurred on 6 August 2012, creating a main scarp 20 m in height (Fig. 2).

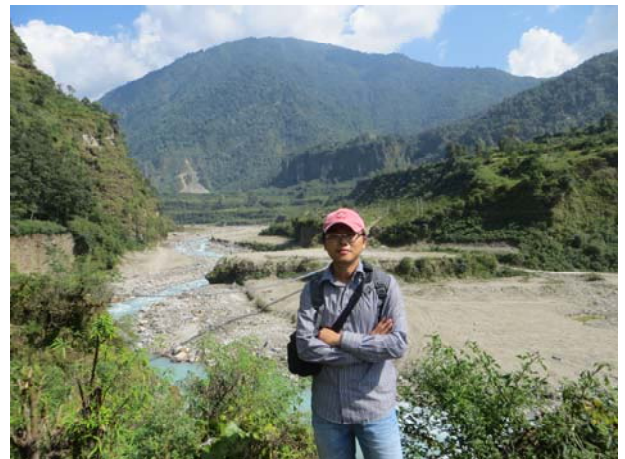
Figure 5: Landslide and debris flow cause by heavy rain and earthquake in Pokhara, Nepal

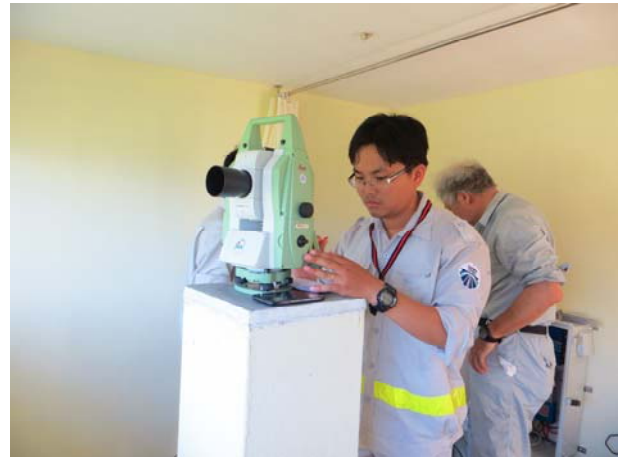
Figure 9: Training on using Total station - Monitoring system in Haivan Station landslide, Da Nang, Vietnam

This monitoring system is consisted by some kinds of sensors and these are installed at the whole landslide area. The five extensometers are used for alarm and they are installed nearby railway track. Others are used for clarification of mechanism of landslide for early warning. The position of each sensor is decided in consideration of the characteristics. All observation sensors are networked by cable or wireless LAN connection. And all data is transferred to computers in ITST office automatically.

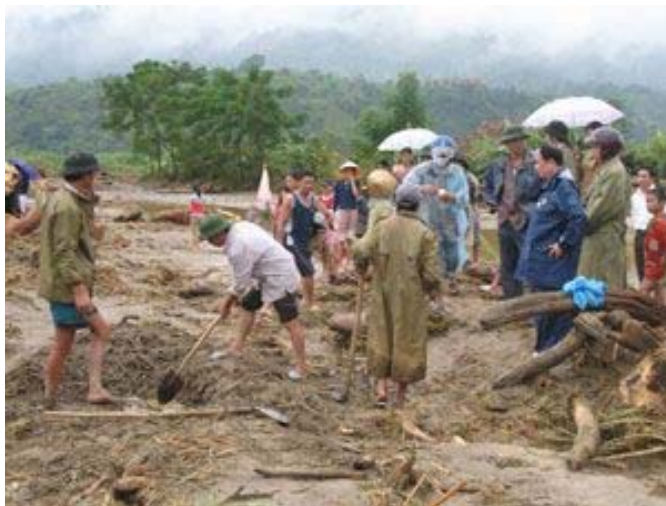
Figure 1 Landslide in Nghe An province, 2007

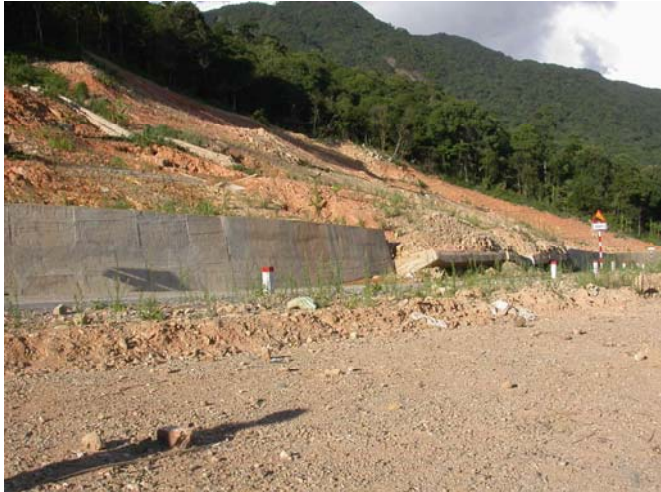
When landslides occur almost materials inside the sliding mass will move simultaneously. On the surface, trees and infrastructures are tilted. Its bent toward the vertical. We

will easily see the scrap and cracks in the top of sliding mass.

Figure 3 Landslide on Ho Chi Minh route

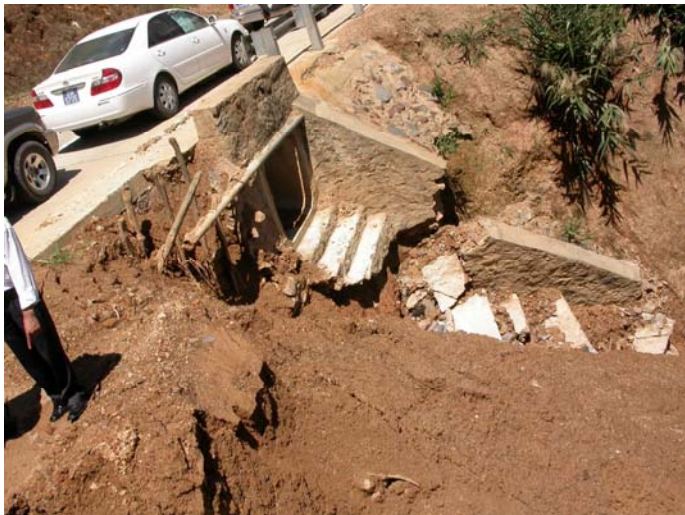
Figure 5 Erosion in Ho Chi Minh route.

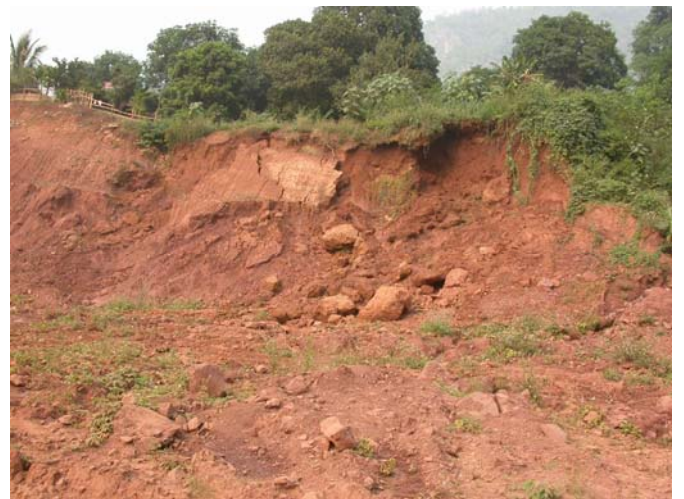
Figure 7 The topple in national road No.6

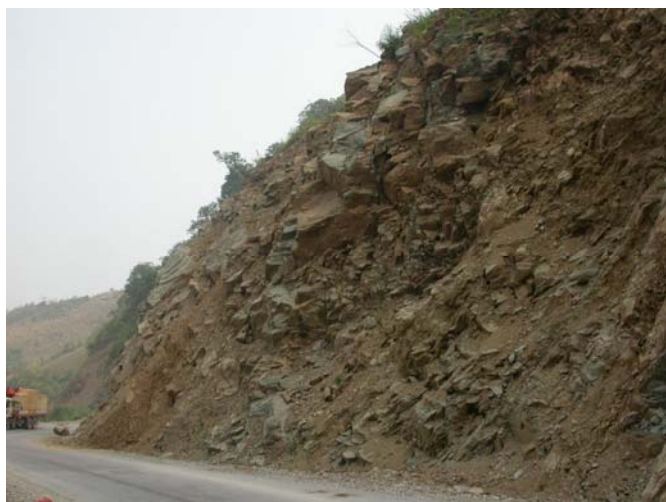
Figure 9 Rock fall on national road No.37

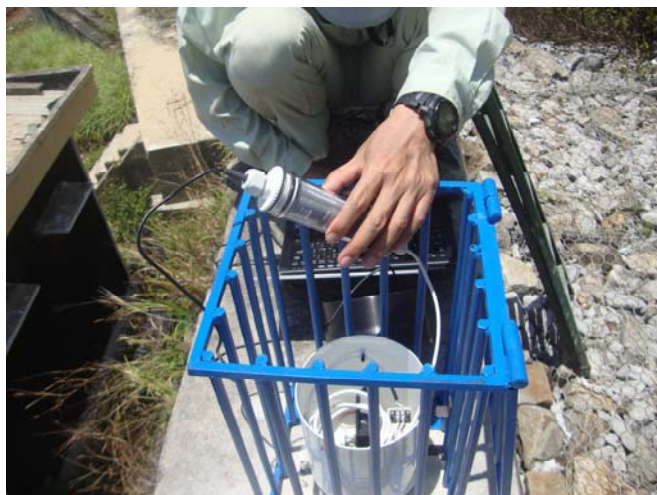
Figure 10 Rain gauge installed in Hai Van station

Landslides are related to rainy season (rainfall and rainy time). So, rain gauge usually uses for landslide monitoring and early warning. The rain gauge can connect to the siren system to warn the community if the precipitation reaches a certain value.

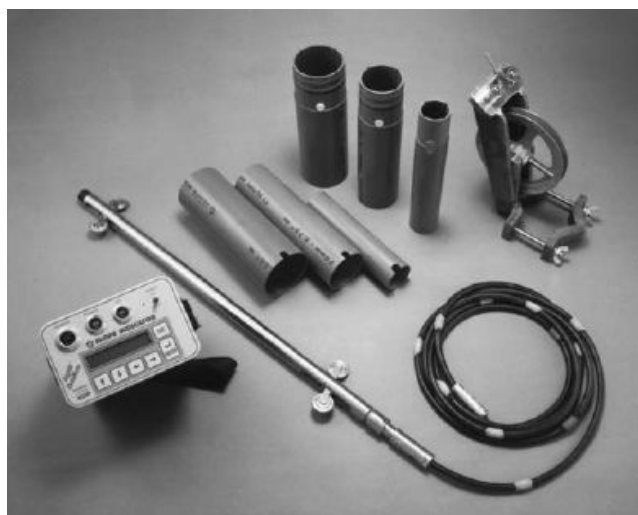
Inclinometers are used for monitoring deformation normal to the axis of a pipe by means of a probe passing along the pipe. Inclinometers are installed to exceed the expected depth of sliding surface. So, the inclinometer provides data for defining sliding surface. At present, Institute of Transport Science and Technology is building the national standard for inclinometer.

Figure 11 Inclinometer system

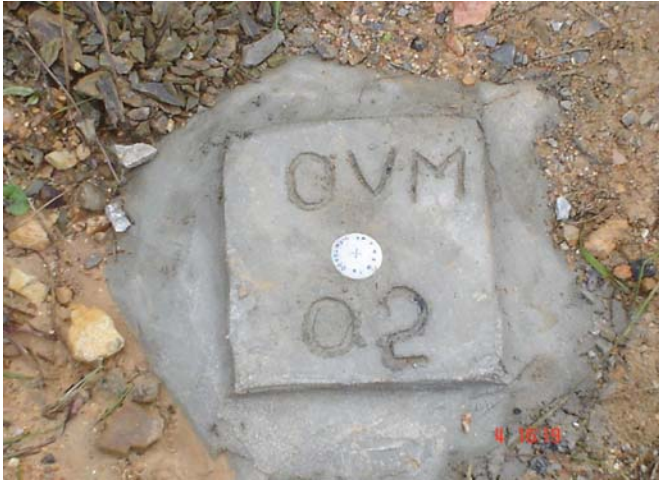
One of the methods of landslide monitoring is to install posts that can be sequentially measured for landslide movement. However, these surface posts can be damaged by animals or people. Wooden, concrete or metal posts in the ground can be directly installed into a landslide. In addition, some stable reference points beyond the boundary of the moving landslide are needed.

Figure 12 Concrete post for landslide monitoring

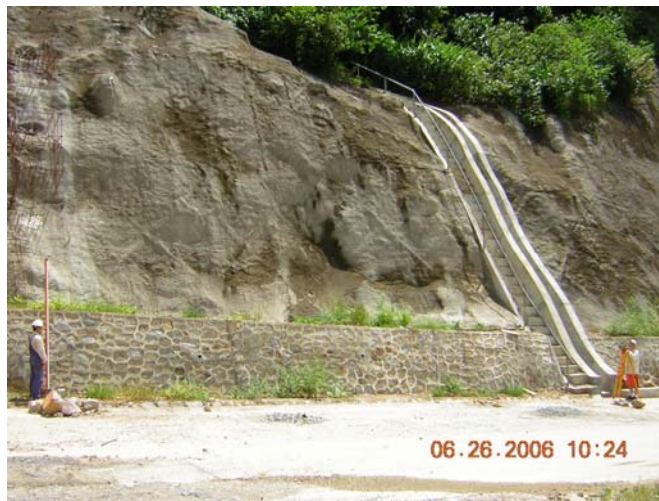
Figure 13 Geodetic measurement for landslide movement

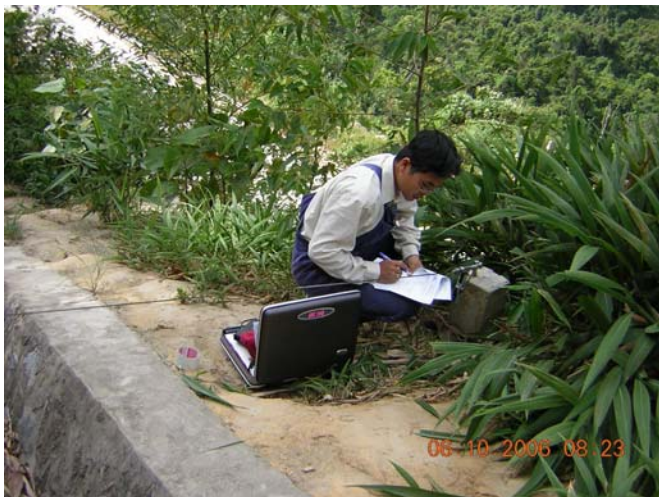
Figure 14 Checking the data of extensometer

Installation of extensometers is similar to establishing movement posts except for the wire connection between the landslide and the stable location adjacent to the landslide. For slow-moving landslides, it may be difficult to determine the location for installing a stable base for the extensometer. Additionally, if the ground is generally

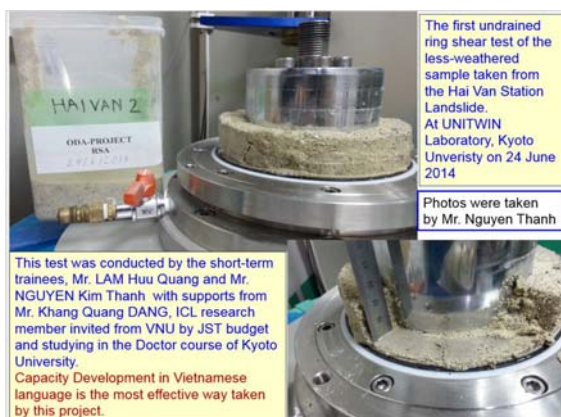
Figure 1. The first testing RSA with Hai Van sample

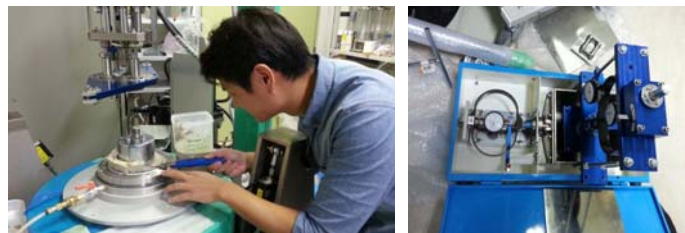
Figure 2. testing RSA with Hai Van sand and potable direct shear test.

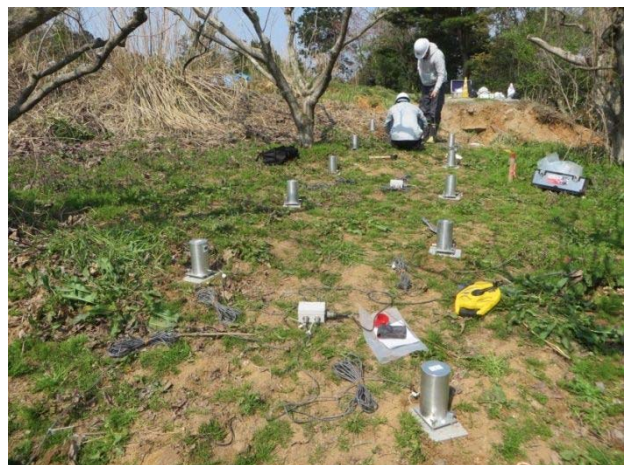
Figure 5 Microtremor survey in Sorayama landslide

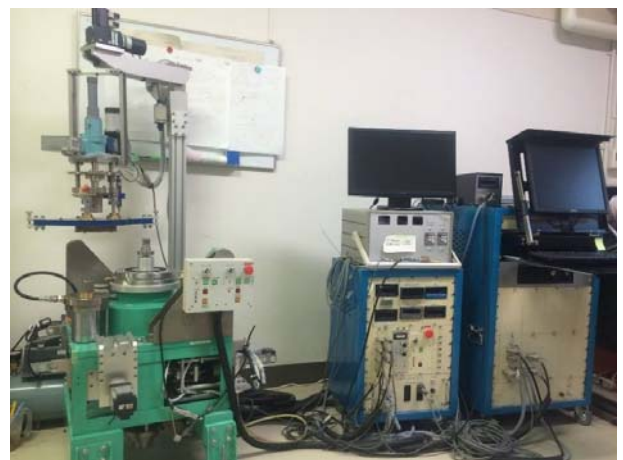
Ring shear apparatus was designed initially to investigate the residual shear resistance along the sliding surface at large shear displacement in landslides because it is unlimited for shear displacement (Sassa et al., 2004). The ring shear test was introduced by Hvorslev (1939) and improved by Bishop (1971), Bromhead (1979), Savage and Sayed (1984), Sassa (1984), Hungr and Morgenstern (1984), Tika (1989), and Garga and Sendano (2002). Ring shear apparatus (ICL-1) was developed for Croatia with maximum normal stress in undrained condition is up to 1 Mpa. Fig.1 present the general view of the portable ring shear apparatus.

Fig 1. General view of the portable ring shear apparatus, ICL-1

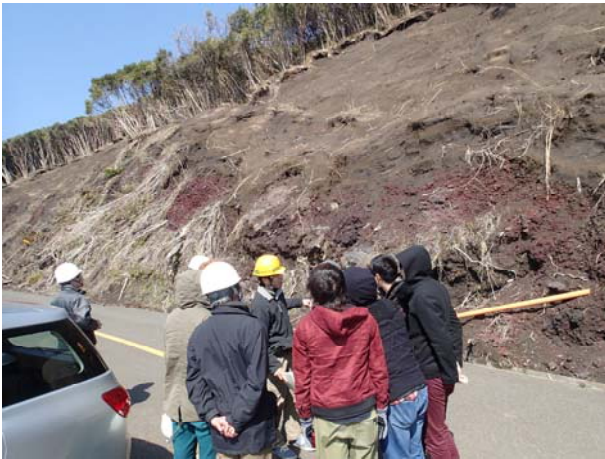
The field investigation were carried out in the collapse area. An average depth of the surface slope collapse was evaluated of 0.92 m by Cone Penetration Test. This test is

a method used to determine the geotechnical engineering properties of soils and delineating soil stratigraphy.

Figure 1 Field investigation in the collapse area

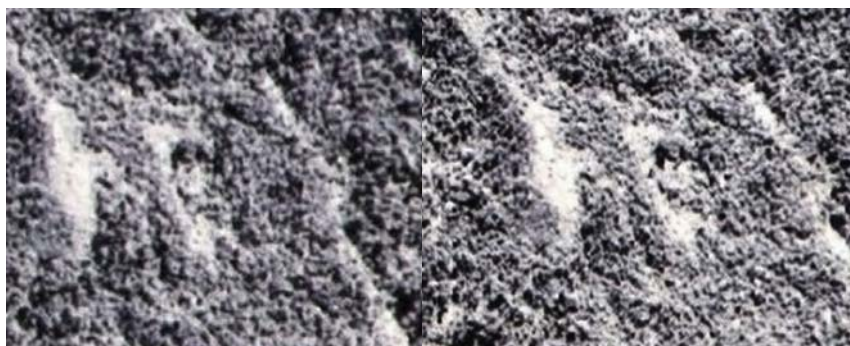
Figure 6 Stereo pair aerial photograph (D2-99-06-415 & 416) showing a typical rotational slide

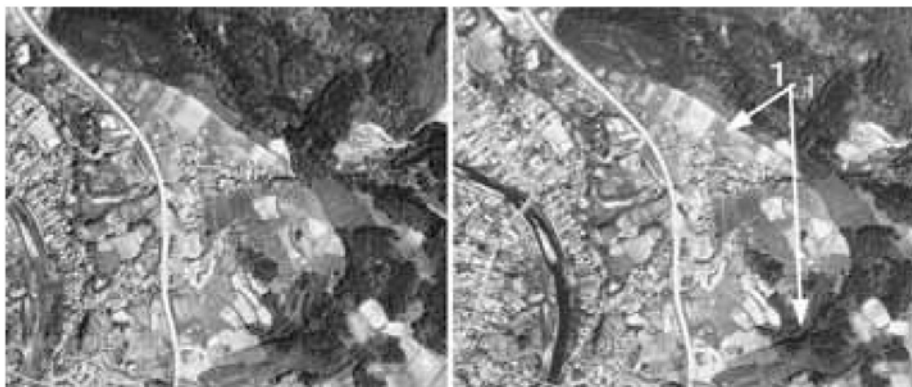
Figure 8 Major boundary of landslide. This is the case of suspended landslide. There is talus topography (1) developed between the main scarp and the body. The weight value is 1.8 (Miyagi et al., 2004).

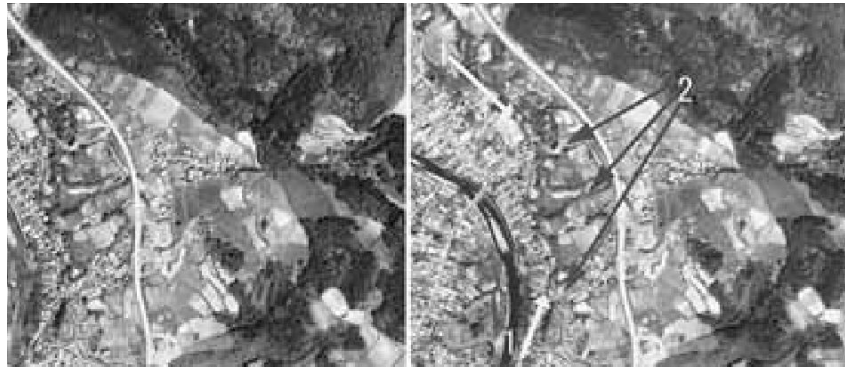
Figure 13 Gullies development. Weight value: 3.6. The normal erosion processes will appear at the suspended stage. Gully erosion is one of the clear and easy to interpretational features. 1; Lateral erosion by stream cut the toe part of the body. 2; Gullies start the dissection to the toe part of body (Miyagi et al., 2004).

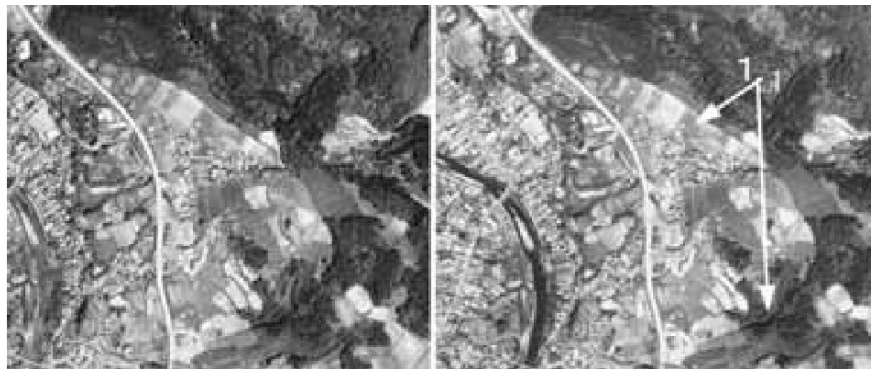
Figure 14 Major boundary of landslide. This is the case of suspended landslide. There is talus topography (1) developed between the main scarp and the body. The weight value is 1.8 (Miyagi et al., 2004).

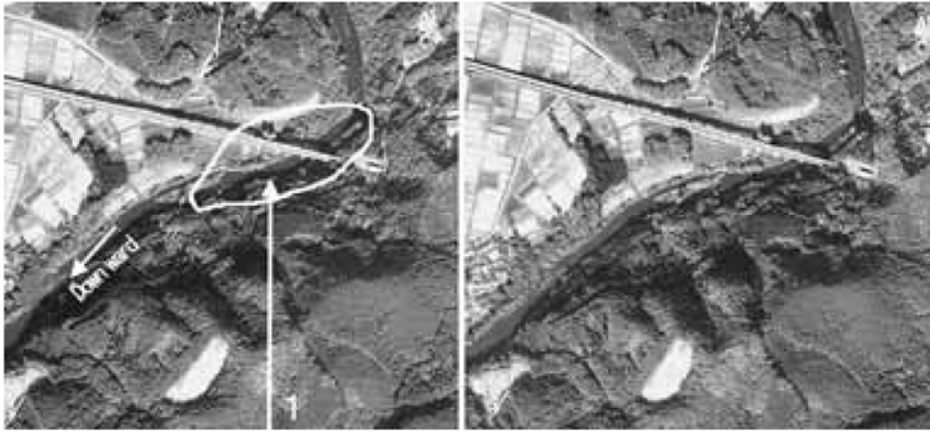
Figure 20 Landslide body and adjacent environment. Landslide body at lower face to the other near. Increase toward the active condition. Weight value: 8.6. Landslide body face to the undercutting slope of river stream has very high potential of landslide (Miyagi et al., 2004).

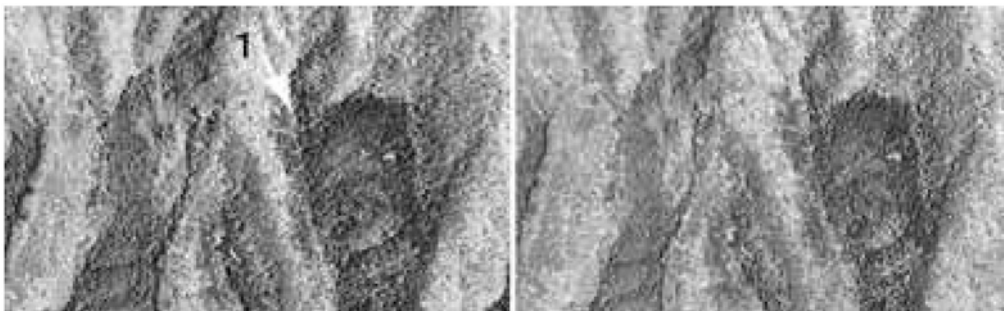
Figure 22 Landslide body and adjacent environment. Landslide body at lower face to the other near. Decreasing (stabilizing order). Weight value: 0.9. The landslide body moved but if it stop by any barrier the potential of reoccurrence should be decrease (Miyagi et al., 2004).

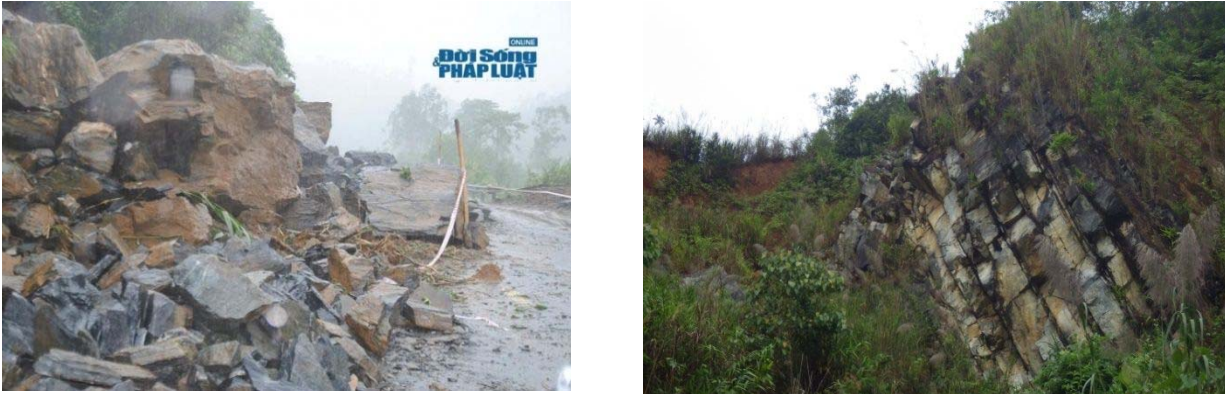
Fig. 5.1 Rockfall on HCMR– Quang Nam section – Vietnam

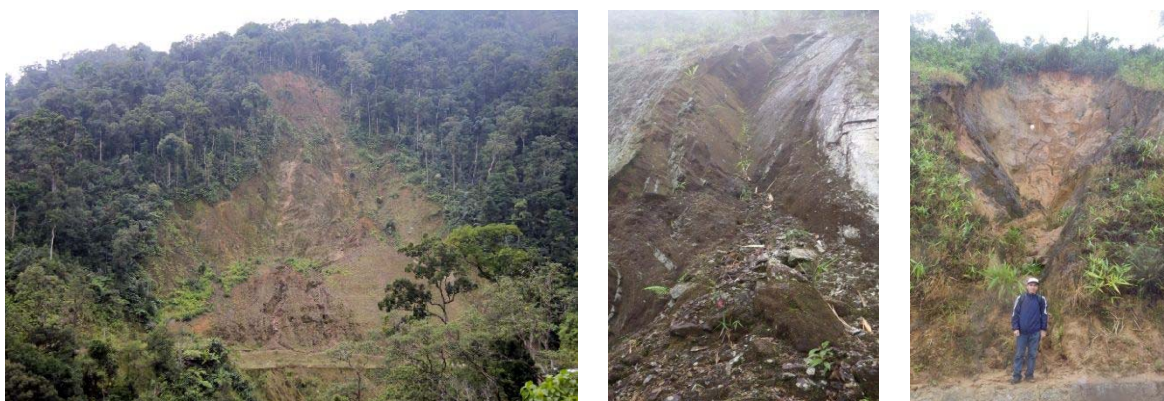
Fig. 5.2 (a)Debris Shallow landslide and (b), (c)Translational wedge type slides in HCMR -Hue section-Vietnam

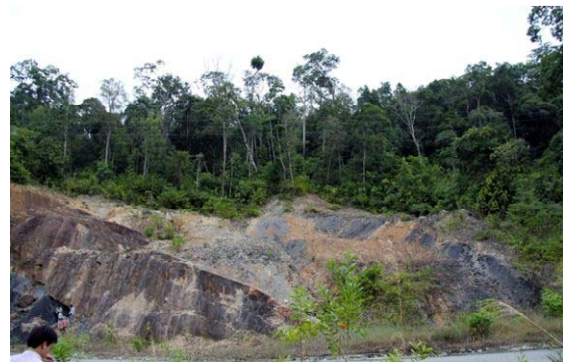
Fig.5.4 Photo of Translational rock slide Northwestward of Thach My town

In the study area, a number of topographic area of deep-seated landslide distributed. Among of them, the huge landslide distributed at the west point of Kham Duc town, Northwestward of Thach My town and Hai Van pass. The huge landslide distributed at the west point of Khom 9 - Kham Duc My cause by the relationship with the characteristic of ultra-basic rock. Topography map of this Translational rockslide is presented in Fig. 5.4-b. Regarding landslide Topography map, a deep seated landslide original form changes in to many minor debris flows inside its landslide body. B means block slide; D means debris flow. The cause of the one near the Thach My town on HCMR was relation of existance of coal layer between rock layers. The photo of translational rockslide North West ward of Thach My town is presented in Fig. 5.4-a.

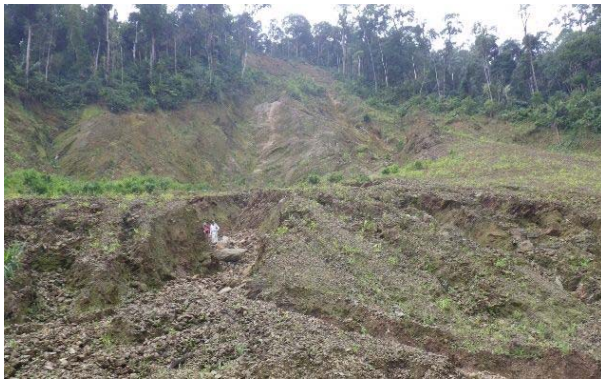
Fig. 5.5-a Photo of landslide body of a rotational landslide in HCMR (Quang Nam section)

The sliding movement of the deflection and accumulation zone of deep landslide created cracks and in some cases put up pavement or facilities of road over and they is continues to move with slow velocity depending on the water absorption of the sliding block. Fig. 5.5-a presented main scarp of a rotational landslide and Fig. 5.5-b presented the body a rotational landslide and in HCMR (Quang Binh section).

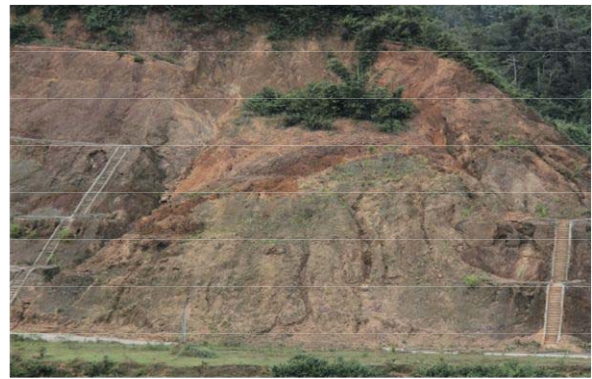
Fig. 5.5-b Photo of main scarp of a rotational landslide in HCMR (Quang Binh section)
