Development of Landslide Risk Assessment Technology along Transport Arteries in Vietnam

Proceedings of the Final SATREPS Workshop on Landslides

13 October 2016, Hanoi, Vietnam

Published by
Institute of Transport Science and Technology (ITST)
International Consortium on Landslides (ICL)

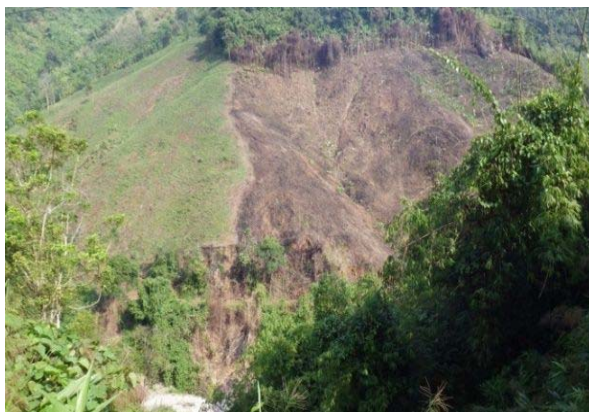
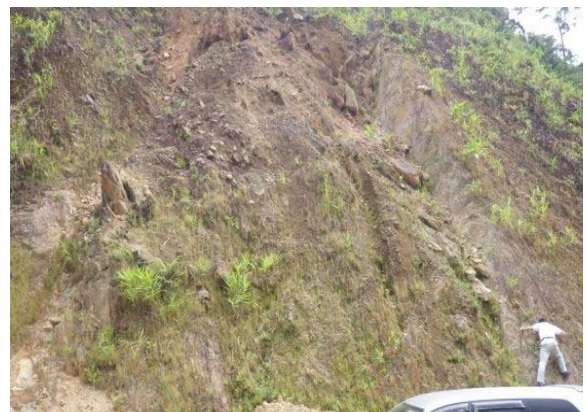
Fig. 5.6 Debris Flow and gully on HCMR-Hue Section-Vietnam

In study area, gully type slides and debris flows, by which an arc-shaped sliding mass originating at the upper area of a slope slides down the slope surface, and the morphology resembles an erosional gully. The development of the small gullies is the initial manifestation of the phenomenon due to the movement of soil particles or fragments of weathering surface, which has resource from broken type of geology wedge structure running follow surface water stream. The small gullies develop larger and larger, and created deep gullies on the surface of slopes, and in some cases, they link together and as the result the slopes failure occurred. Pictures of debris flow and gully on HCMR-Hue section-Vietnam is presented in Fig 5.6.

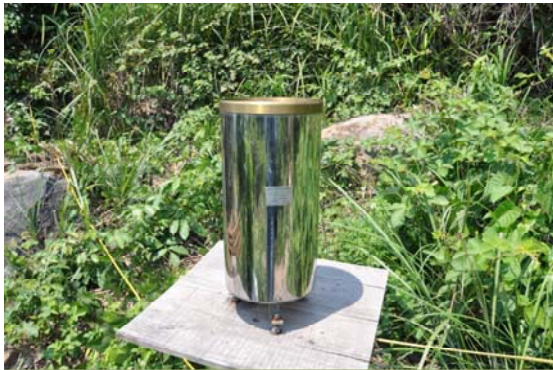
Fig. 6.3-a shows a picture of a rain gauge, which is often used to measure the amount of precipitation. The rain gauge consists of a funnel that collects and channels the precipitation into a small container.

Fig. 6.3 Rain gauge

After a pre-set amount of precipitation falls, the lever tips, dumping the collected water and sending an electrical signal. A rain gauge can be used for measurement of precipitation of a region.

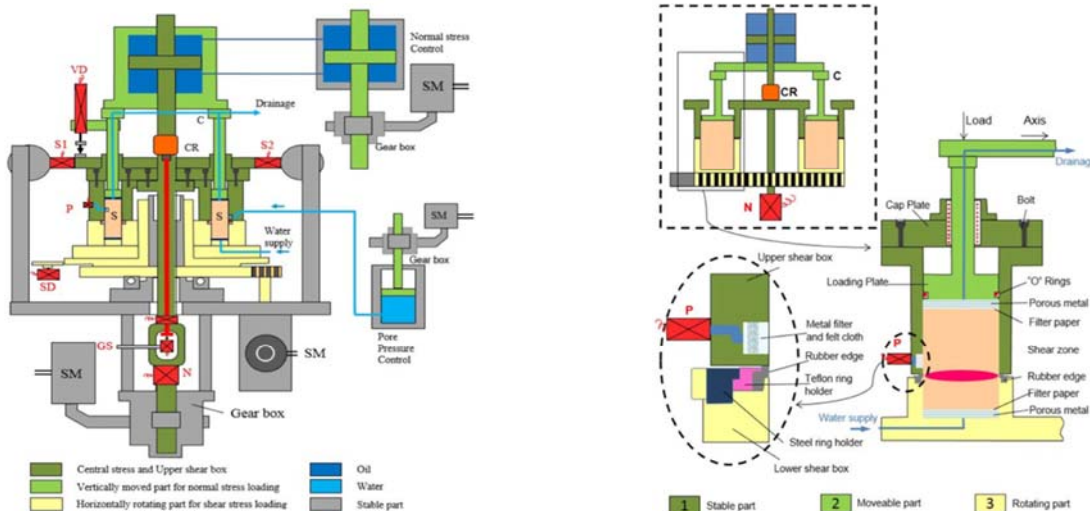
Fig. 1 The new high-stress dynamic-loading ring- shear apparatus (ICL-2)

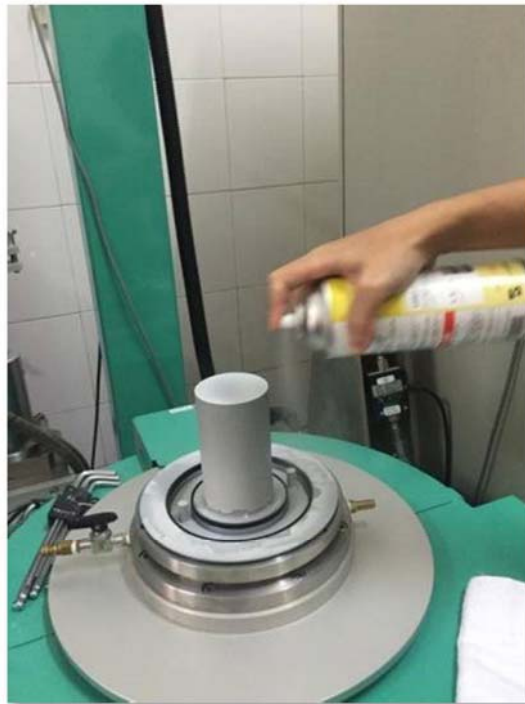
Teflon is sprayed separately with three times to protect the rubber edges, in which, the time of each Teflon spray is about 10 minutes to dry Teflon coats (Fig. 2).

Fig. 2 Teflon Spay

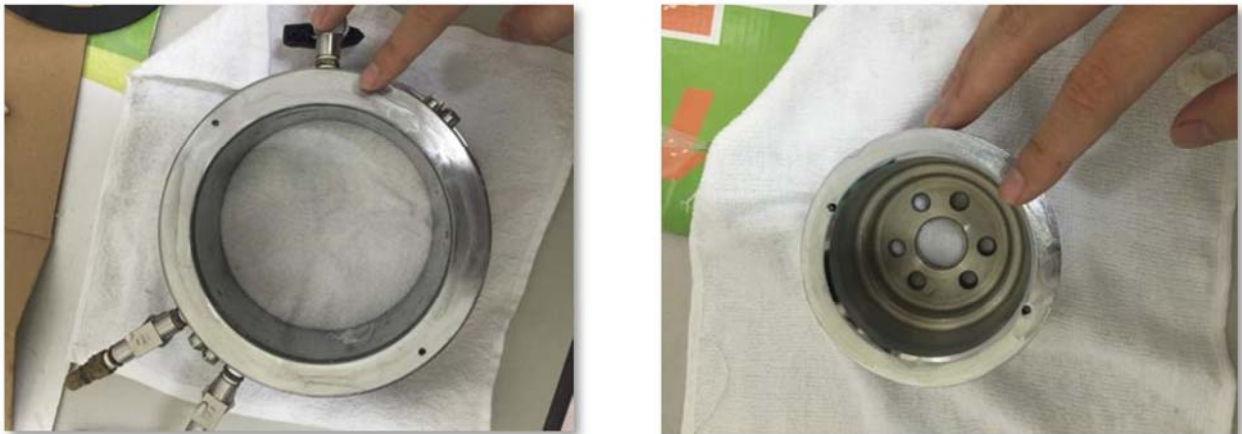
Fig. 3 The inner and outer rings are covered in grease

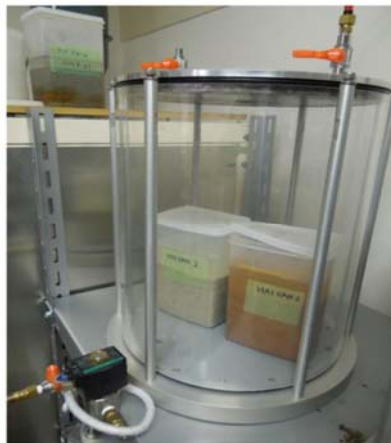
- Next day, the specimen is saturated by using a vibrator in combination with a vacuum pump. In order to finish this step, leave the sample in the vacuum tank without further vibrations during night. Depending on types of sample, it will take several hours to make air bubbles inside soil particles come out. Even it may take some days to saturate samples that have a very low permeability like clays and silts.

Fig. 4 Vacuum tank

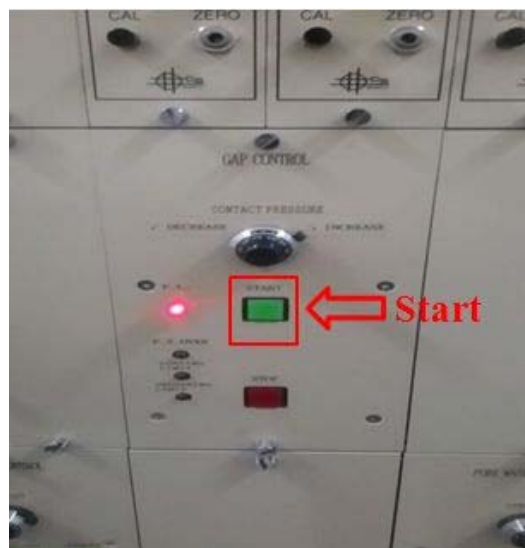
Fig. 5 Switch on GAP control

- Firstly, run Ring Shear Simulator Software on PC and switch on Gap control (Fig. 5).
- Secondly, screw the inner ring and adjust vertical load to 0 by reset the value of normal stress (Fig. 6). Normally, vertical load is always to be zero at the neutral position of Gap control button.

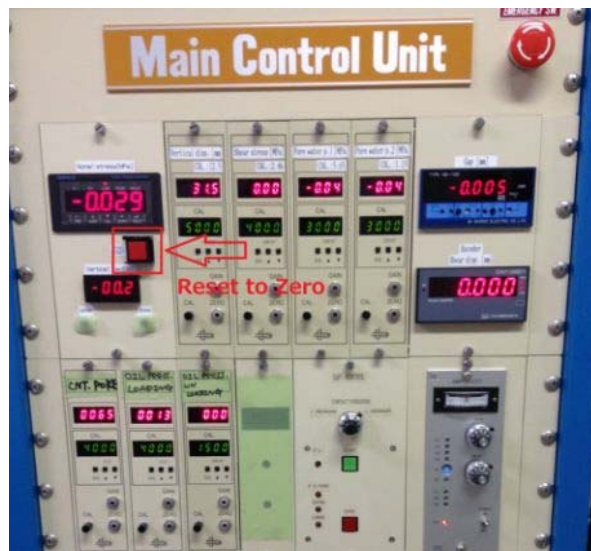
Fig. 6 Reset Gap value to zero

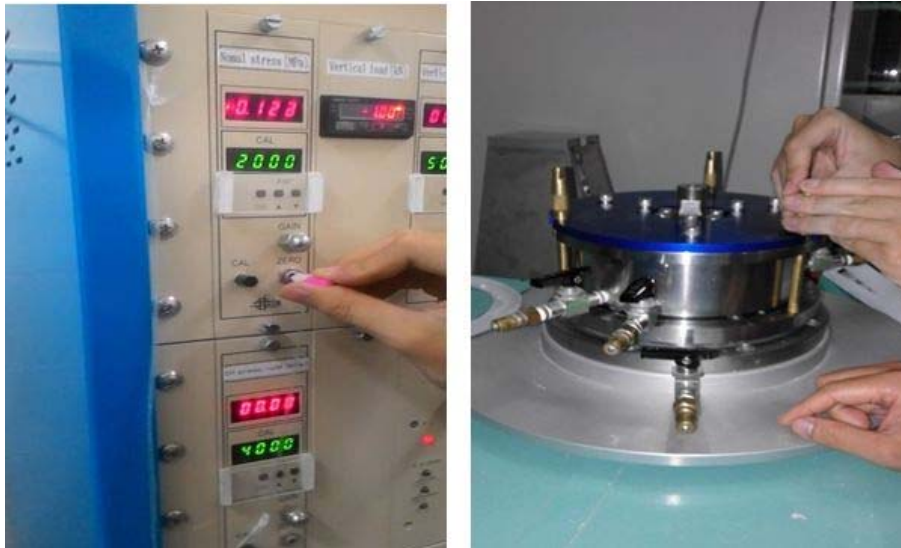
- Once contact force is increased to a designed pressure of Gap value, Helping Screws are screwed tightly and then remove the Helping Ring (Fig. 8).

Fig. 8 Increasing Contact pressure and removing the Helping Ring

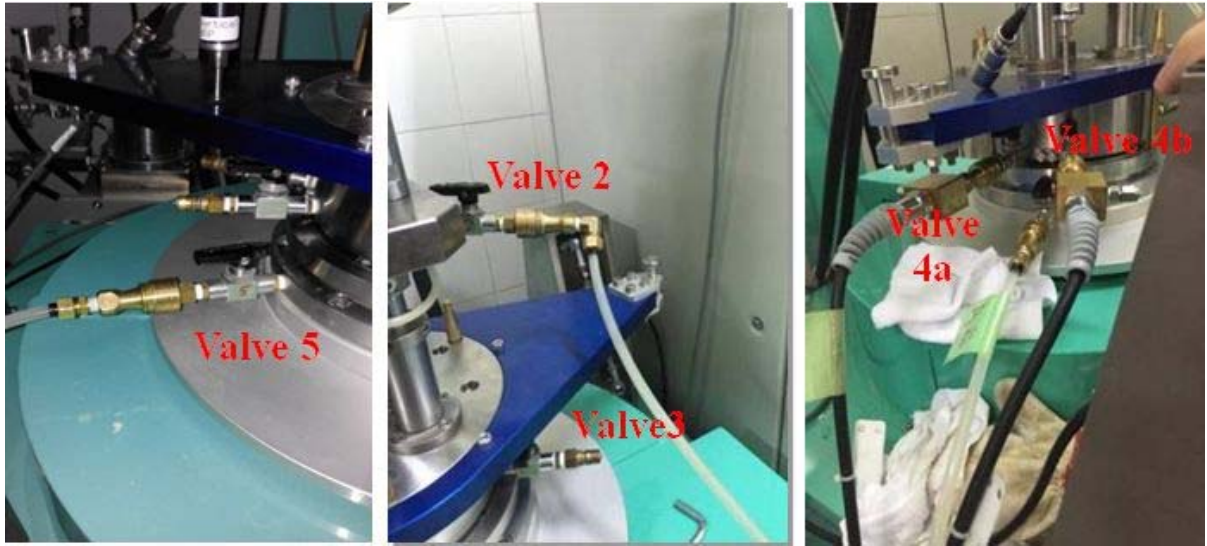
Shear box without sample is filled with CO₂ and de-aired water. Then, saturated sample that is prepared by de- aired could be slowly placed in shear box. After that, the water circulation could start to enable full water saturation of the sample. De-aired water is slowly supplied through the lower drainage line, and discharged from the upper drainage line until all air bubbles are expelled. Valves 2, 3, 4a and 4b are de-aired by CO₂, respectively (as shown in Fig. 10).

Fig. 10 Procedure of CO₂ and H₂O

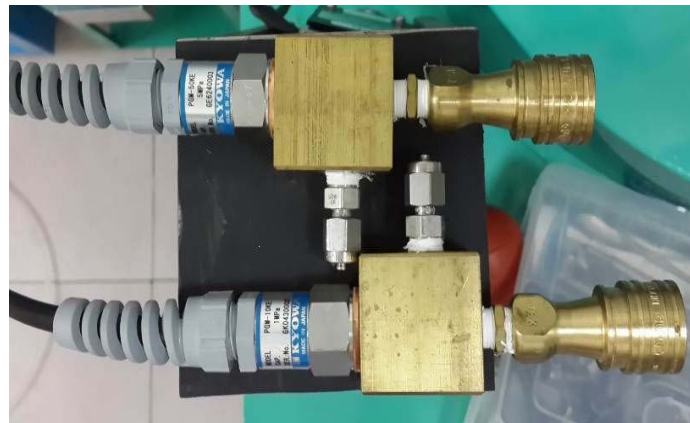
After de-airing water, PPT-1 and PPT-2 are installed to Valve 4a and Valve 4b, these valves are drained to exclude air bubbles from the inside (Fig. 11).

Fig. 11 A photograph of pore water pressure transducers PPT-1, PPT-2

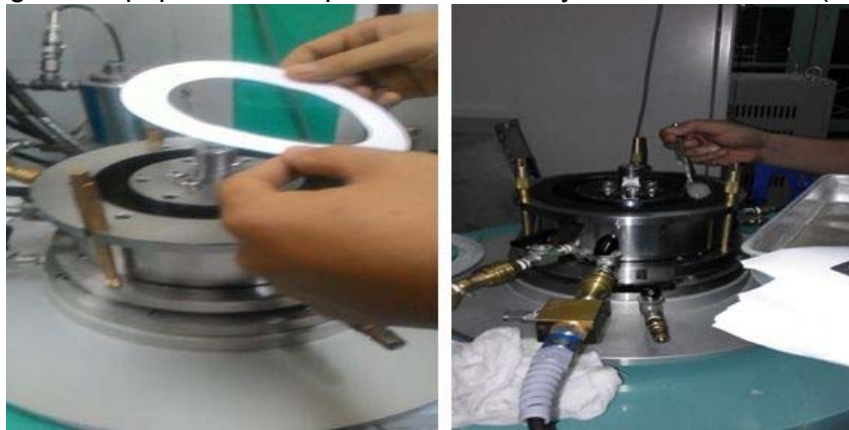
After putting a filter paper, the sample could be slowly built in shear box (Fig. 12).

Fig. 12 Putting a filter paper and building the sample

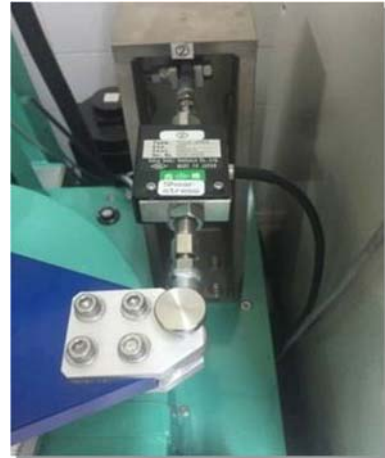
Fig. 14 Installing Shear Load Cells

Once two shear load cells are set up after installing shear box and loading plate (as presented in Fig. 14), 12 screws must be screwed tightly. Later on, the lifter of upper loading plate is returned back to neutral position and to be locked.

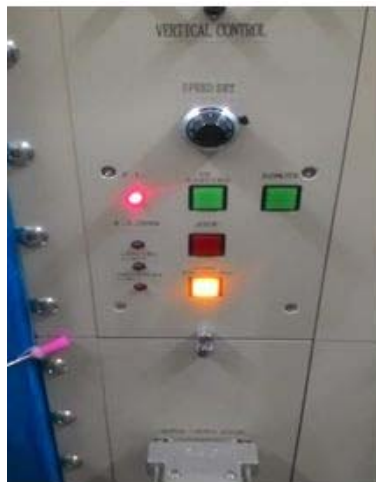
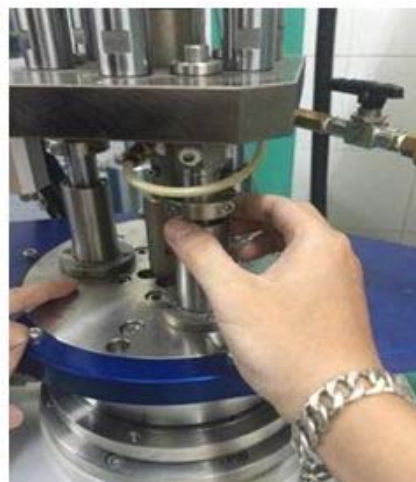
After screwing 12 screws on LP, Vertical Load Cylinder (VLC) is lowered to connect to the central axis of the apparatus (Fig. 15). In addition, one important thing needs to do is that the fixer which prevent the drop of the upper loading part by self-weight must be unlocked and removed from the pillars after sample setting. Fixers are only fixed until sample setting and those should be unlocked during loading. Otherwise, normal stress can not load and it may lead to some damages to the apparatus.

Fig. 15 Installing VLC and unlocking the fixers

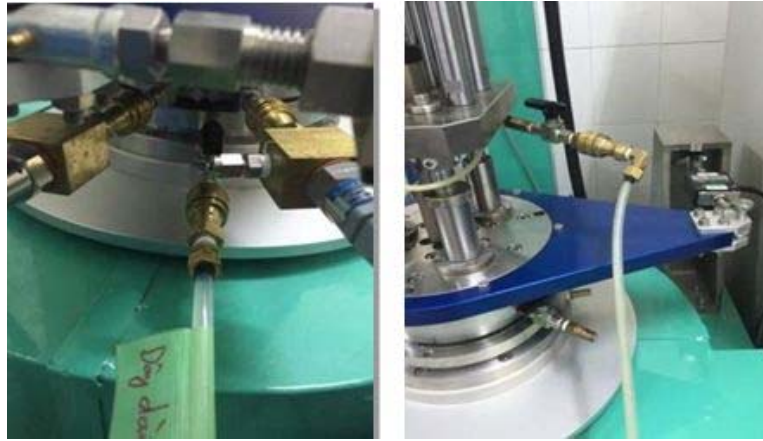
Finally, a water circulation by gravity can start to fully saturate shear box and the sample. In water circulation, de-aired water is supplied through the lower drainage line (valve 5), and discharged from the upper drainage line (valve 2) until all air bubbles are expelled (Fig. 16).

Fig. 16 De-aired water flow to valve 5 and discharge at valve 2

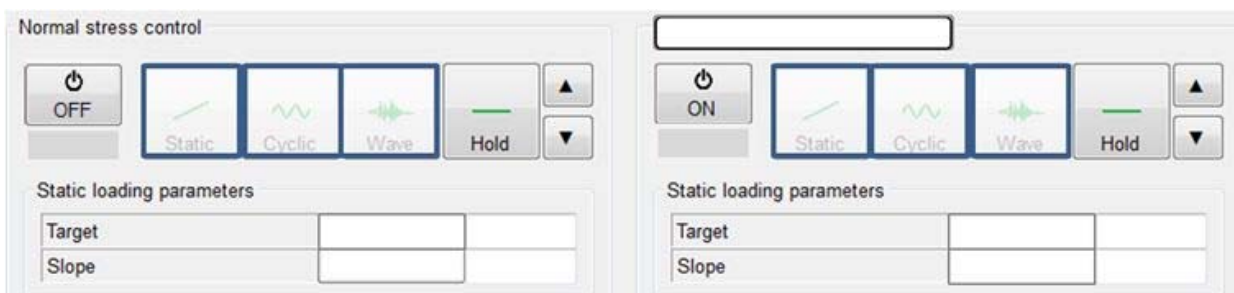
Sample consolidation is carried out in order to reproduce the initial stress condition of the sample. The initial stress state of soils only due to gravity is created by loading normal stress and shear stress that depend on the depth of samples at the suspected sliding surface, slope angle and unit weight of the sample. After making input data form panel for Data acquisition with appropriate parameters, data acquisition is switched on and stress loading can be apply while Valve 02 is opened. The rate of normal stress and shear stress increasing ranges from 1 kPa to 5 kPa per second for ICL-2 tests. When shear stress and normal stress reach to designed values and pore water pressure dissipates completely (values at u_1, u_2 is zero), valve 02 is closed to turn shear box to undrained condition. Fig. 17 illustrates the input data window for normal stress and shear stress of the ring shear tests.

Fig. 17 Photograph of input data window for sample consolidation

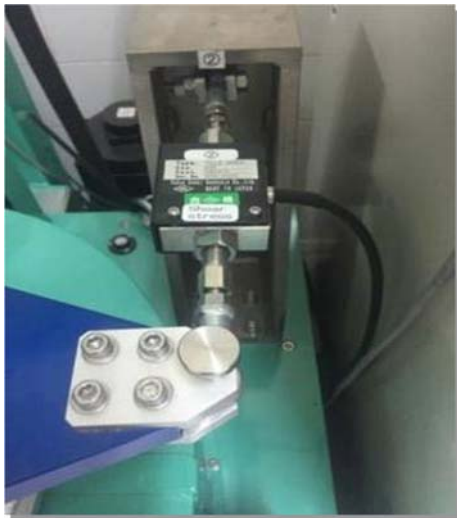
- Disconnection of monitoring equipments: including Shear Load Cells (Fig. 21), Vertical Displacement Sensor from the Vertical Load Cylinder, and reinstalling VLC (Fig. 22), the piston is returned to initial position, then lock protection screw.

Fig. 21 Shear Load Cells

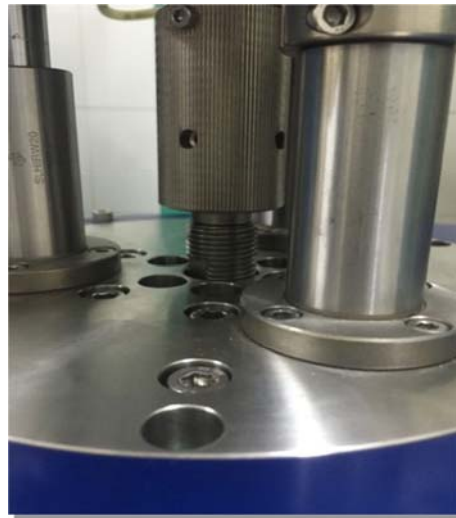
Fig. 22 Disconnection of VLC and central axis

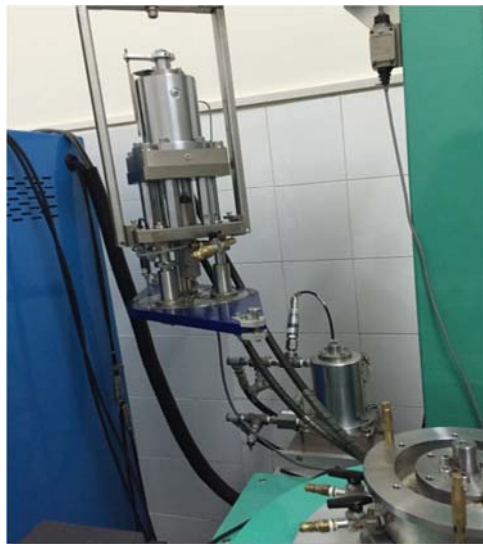
- Removal of Loading Plate: Firstly, fix the shear box with 3 helping screws, then unscrew 12 connected screws between Loading Plate and shear boxes, finally remove Loading Plate from shear box and put Loading Plate back the neutral position (Fig. 23). When pulling Loading Plate, drain valve should be opened to let airs enter or get out of shear box. This work enables to release pressure within SB for smoothly reinstalling Loading Plate.

Fig. 23 Reinstalling Loading Plate (the plate in dark blue color)

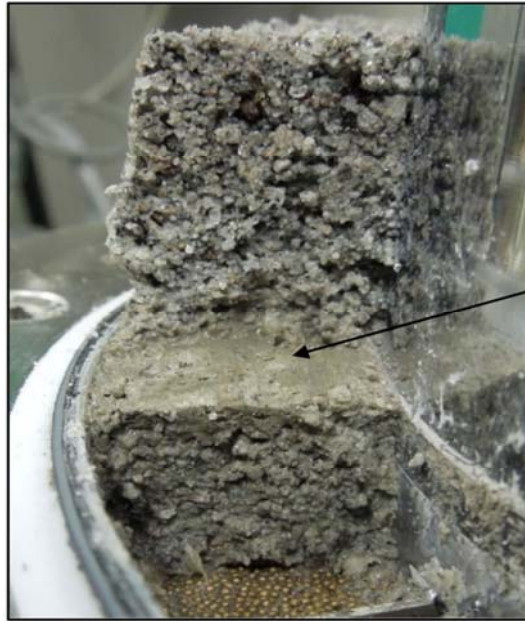
- Removal of the sample: If some parts of the sample are going to be used for other tests, make sure to remove the shear zone. Otherwise, all samples will be disposed. In case of determining saturated unit weight, dry weight and the water content of the sample, after doing the test, all sample including filter paper and tissues should be weight. The sample and sliding surface after testing is presented in Fig. 24.

Fig. 24 Shear zone is presented by a black arrow

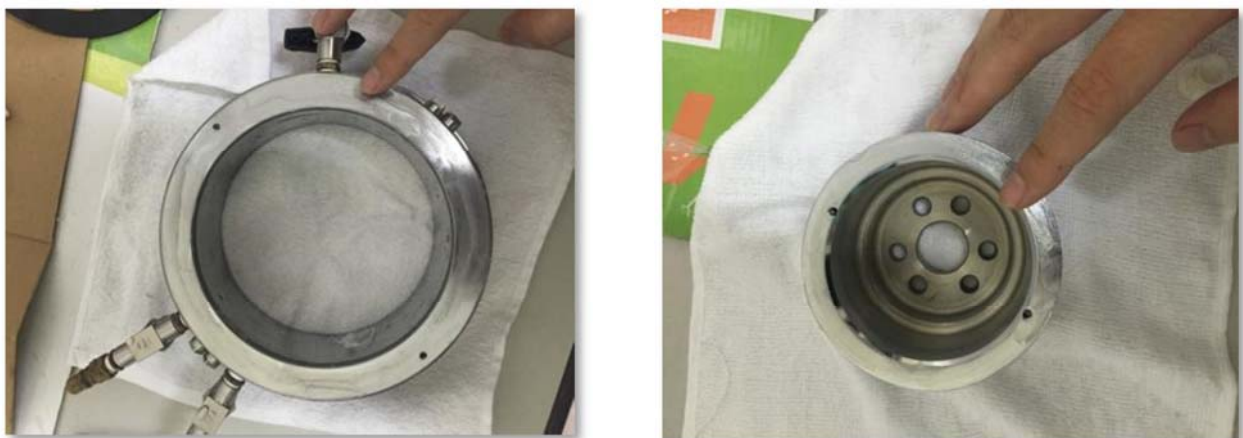
Silicon grease is coated on the inner and outer rings of upper shear box in order to reduce the friction and to prevent water leakage during shearing (Fig. 3).

Fig. 3 The inner and outer rings are covered in grease

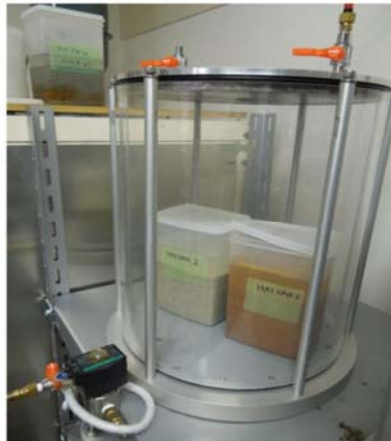
- Next day, the specimen is saturated by using a vibrator in combination with a vacuum pump. In order to finish this step, leave the sample in the vacuum tank without further vibrations during night. Depending on types of sample, it will take several hours to make air bubbles inside soil particles come out. Even it may take some days to saturate samples that have a very low permeability like clays and silts.

Fig. 4 Vacuum tank

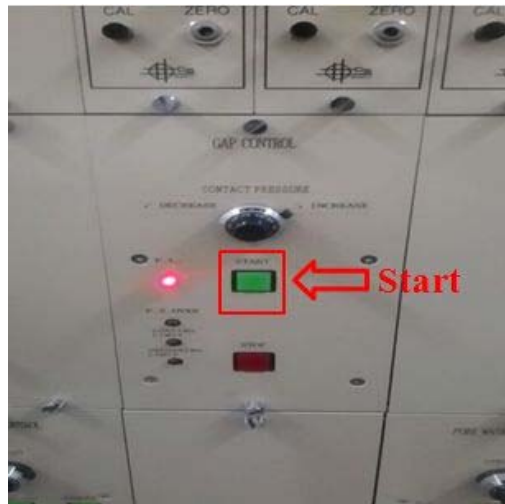
Fig. 5 Switch on GAP control

- Firstly, run Ring Shear Simulator Software on PC and switch on Gap control (Fig. 5).
- Secondly, screw the inner ring and adjust vertical load to 0 by reset the value of normal stress (Fig. 6). Normally, vertical load is always to be zero at the neutral position of Gap control button.

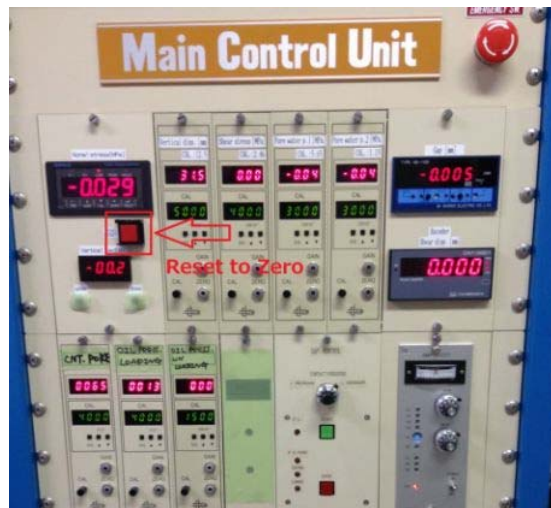
Fig. 6 Reset Gap value to zero

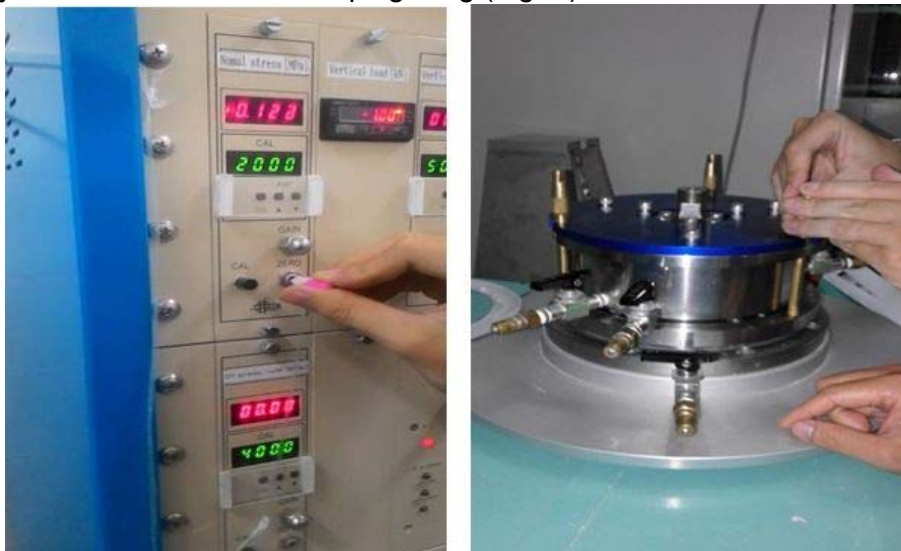
- Once contact force is increased to a designed pressure of Gap value, Helping Screws are screwed tightly and then remove the Helping Ring (Fig. 8).

Fig. 8 Increasing Contact pressure and removing the Helping Ring

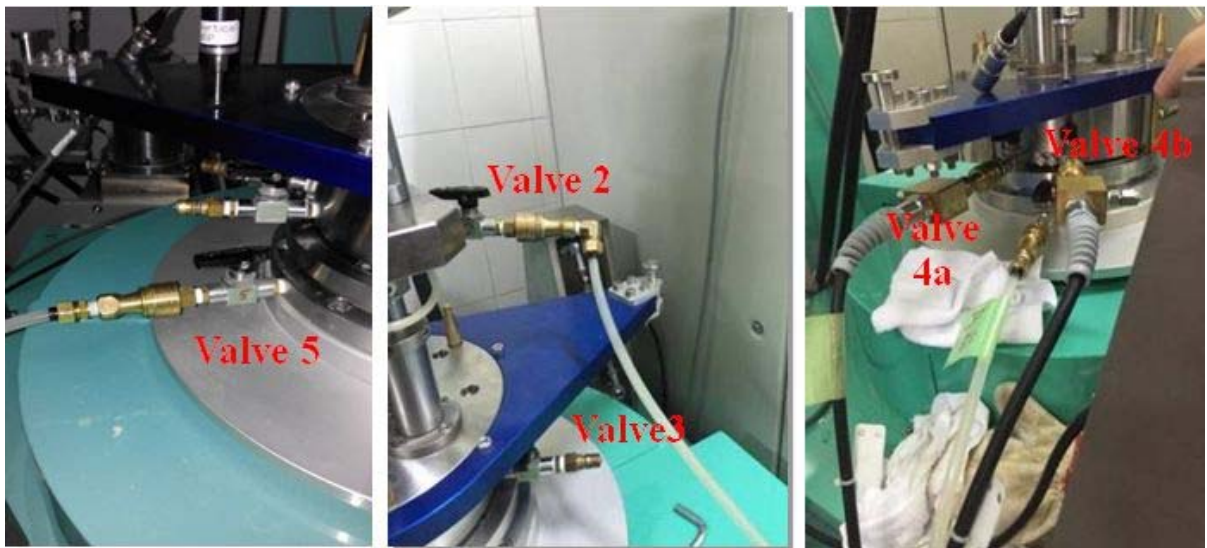
Shear box without sample is filled with CO₂ and de-aired water. Then, saturated sample that is prepared by de-aired could be slowly placed in shear box. After that, the water circulation could start to enable full water saturation of the sample. De-aired water is slowly supplied through the lower drainage line, and discharged from the upper drainage line until all air bubbles are expelled. Valves 2, 3, 4a and 4b are de-aired by CO₂, respectively (as shown in Fig. 10).

Fig. 10 Prodecure of CO₂ and H₂O Saturation

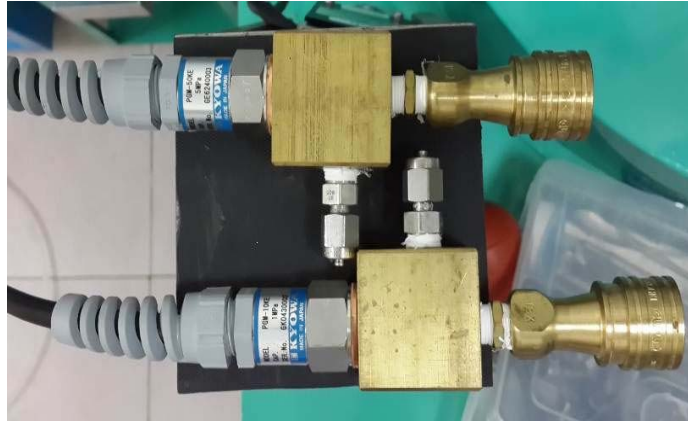
After de-airing water, PPT-1 and PPT-2 are installed to Valve 4a and Valve 4b, these valves are drained to exclude air bubbles from the inside (Fig. 11).

Fig. 11 A photograph of pore water pressure transducers PPT-1, PPT-2

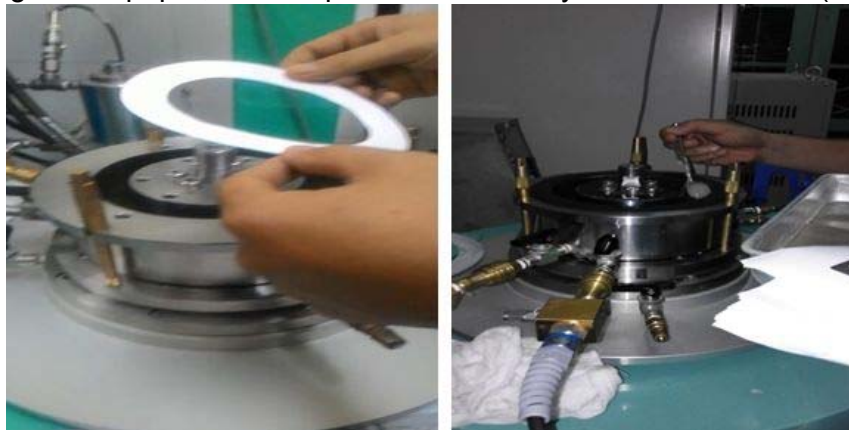
After putting a filter paper, the sample could be slowly built in shear box (Fig. 12).

Fig. 12 Putting a filter paper and building the sample

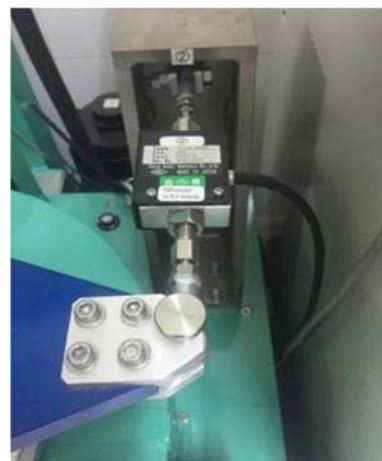
Fig. 14 Installing Shear Load Cells

Once two shear load cells are set up after installing shear box and loading plate (as presented in Fig. 14), 12 screws must be screwed tightly. Later on, the lifter of upper loading plate is returned back to neutral position and to be locked.

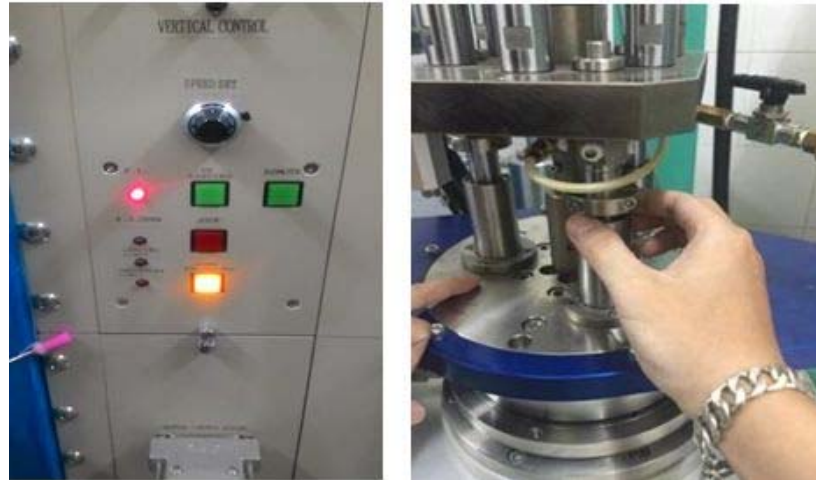
Fig. 15 Install VLC and unlocking the fixers

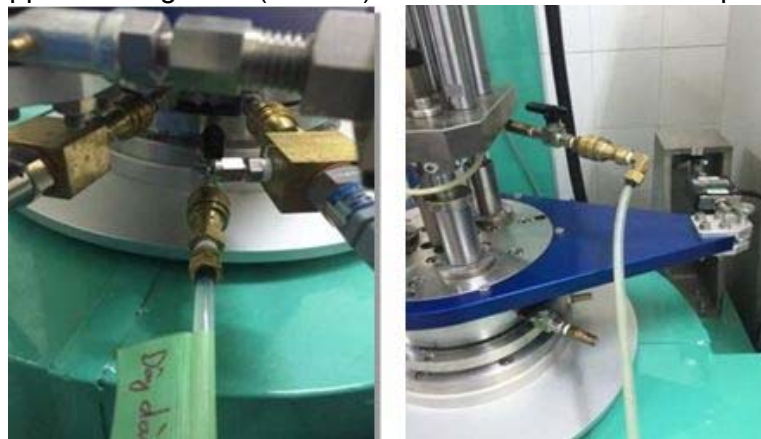
Finally, a water circulation by gravity can start to fully saturate shear box and the sample. In water circulation, de-aired water is supplied through the lower drainage line (valve 5), and discharged from the upper drainage line (valve 2) until all air bubbles are expelled (Fig. 16).

Fig. 16 De-aired water flow to Valve 5 and discharge at Valve 2

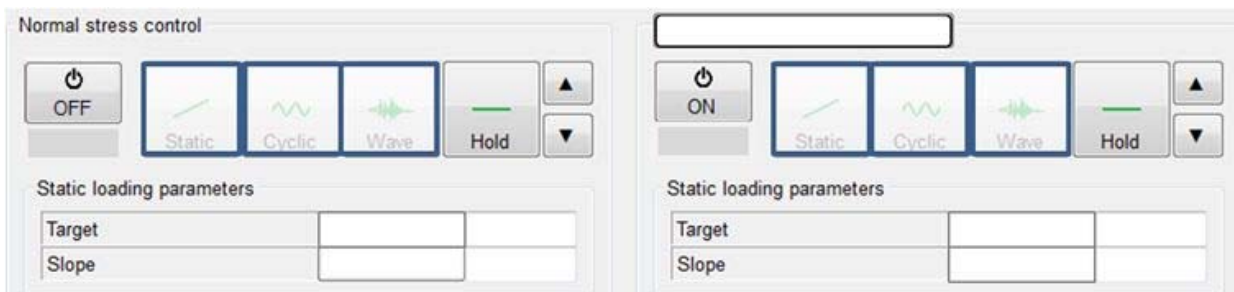
Sample consolidation is carried out in order to reproduce the initial stress condition of the sample. The initial stress state of soils only due to gravity is created by loading normal stress and shear stress that depend on the depth of samples at the suspected sliding surface, slope angle and unit weight of the sample. After making input data form pannel for Data acquisition with appropriate parameters, data acquisition is switched on and stress loading can be apply while Valve 02 is opened. The rate of normal stress and shear stress increasing ranges from 1 kPa to 5 kPa per second for ICL-2 tests. When shear stress and normal stress reach to designed values and pore water pressure dissipates completely (values at u_1 , u_2 is zero), valve 02 is closed to turn shear box to undrained condition. Fig. 17 illustrates the input data window for normal stress and shear stress of the ring shear tests.

Fig. 17 Photograph of input data window for sample consolidation

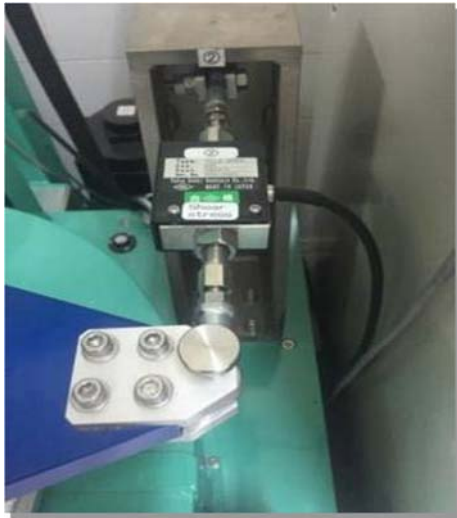
Disconnection of monitoring equipments: including Shear Load Cells (Fig. 21), Vertical Displacement Sensor from the Vertical Load Cylinder, and deinstall VLC (Fig. 22), the piston is returned to initial position, then lock protection screw.

Fig. 21 Shear Load Cells

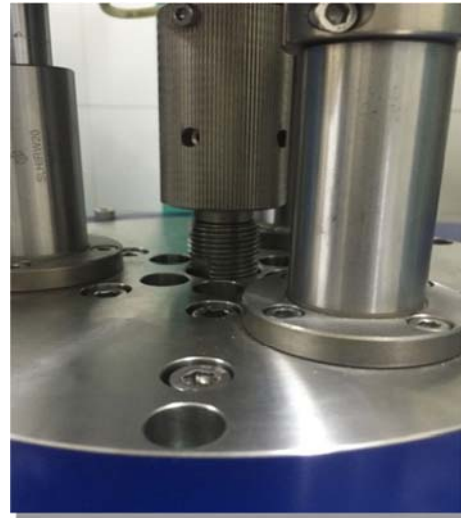
Fig. 22 Disconnection of VLC and central axis

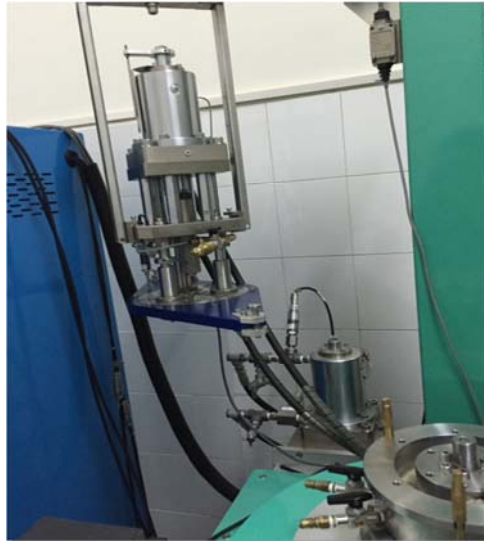
- Removal of Loading Plate: Firstly, fix the shear box with 3 helping screws, then unscrew 12 connected screws between Loading Plate and shear boxes, finally remove Loading Plate from shear box and put Loading Plate back the neutral position (Fig. 23). When pulling Loading Plate, drain valve should be opened to let air enter or get out of shear box. This work enables to release pressure within SB for smoothly deinstalling Loading Plate.

Fig. 23 Reinstalling Loading Plate (the plate in dark blue color)

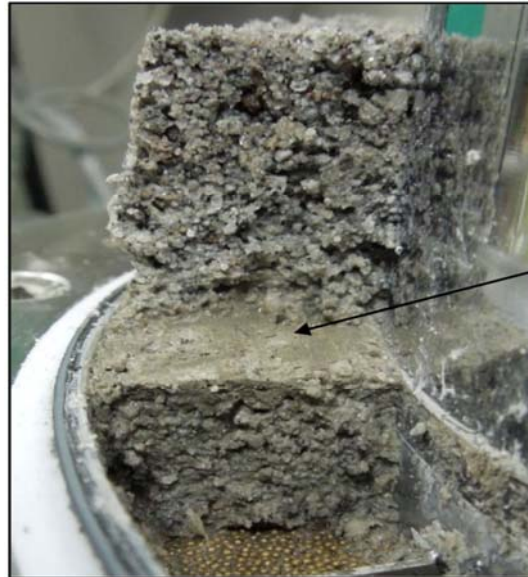
- Removal of the sample: If some parts of the sample are going to be used for other tests, make sure to remove the shear zone. Otherwise, all samples will be disposed. In case of determining saturated unit weight, dry weight and the water content of the sample, after doing the test, all sample including filter paper and tissues should be weight. The sample and sliding surface after testing is presented in Fig. 24.

Fig. 24 Shear zone is presented by a black arrow

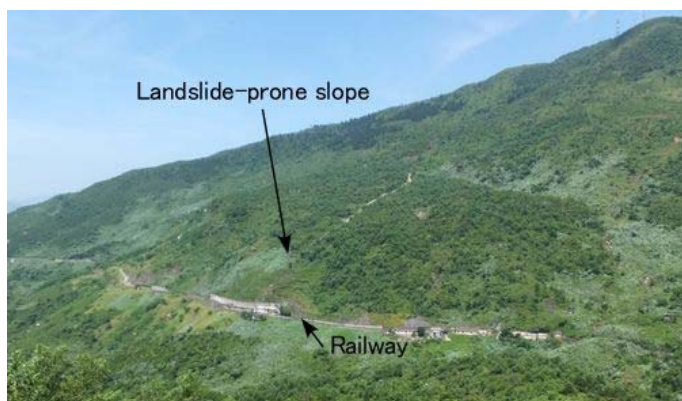
This study was conducted in Hai Van station landslide area. This area located near Danang city in the central part of Vietnam. Because the national railway of Hai Van station is one of the most important lifelines, the safety management of landslide disaster is required.

Fig.2 Landslide slope in Hai van Station (Asano et.al.2016)

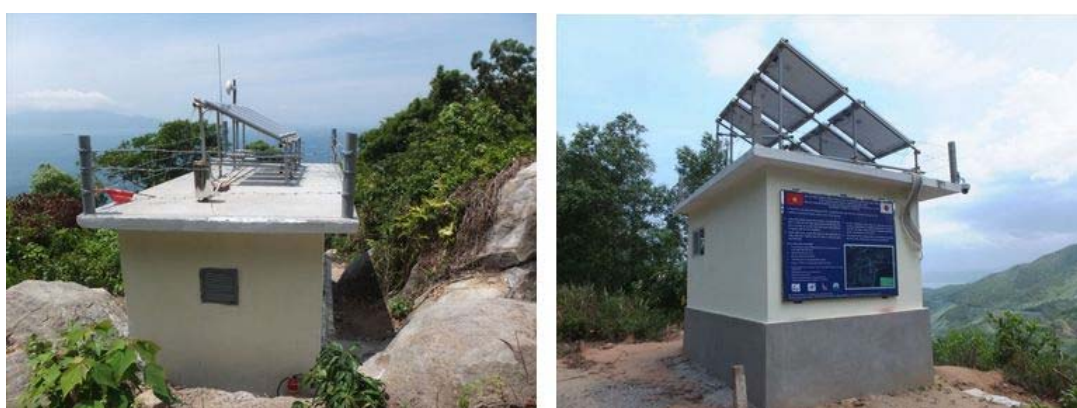
Fig. 5. Monitoring hut (BHH) in landslide slope and monitoring station (TSH) in opposite stable slope (Asano et.al 2016)

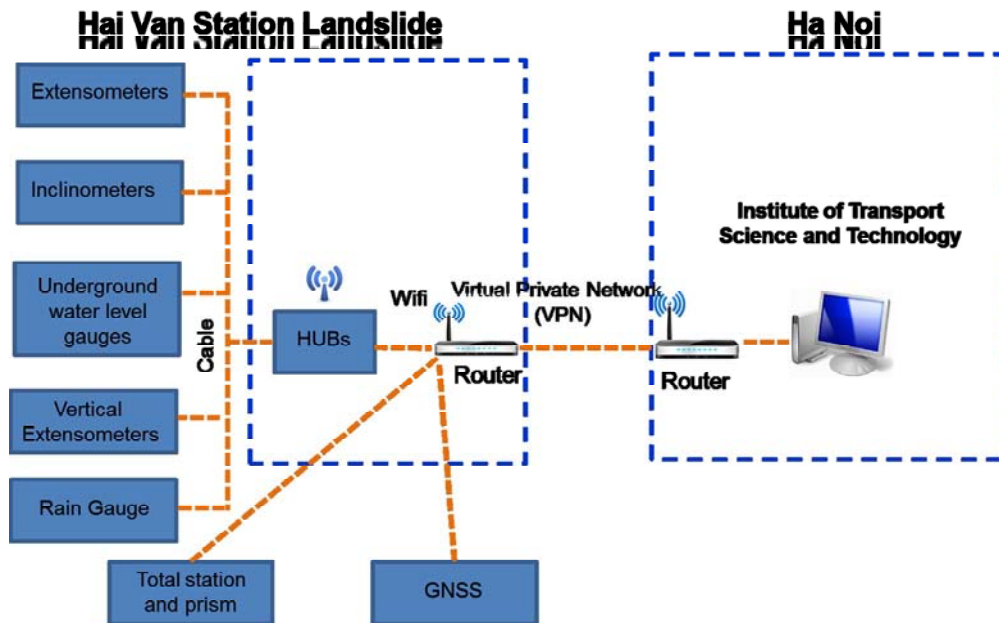
Fig. 6. Schematic map of monitoring system in Hai Van Station landslide and transfer data system from Hai Van Station to Ha Noi

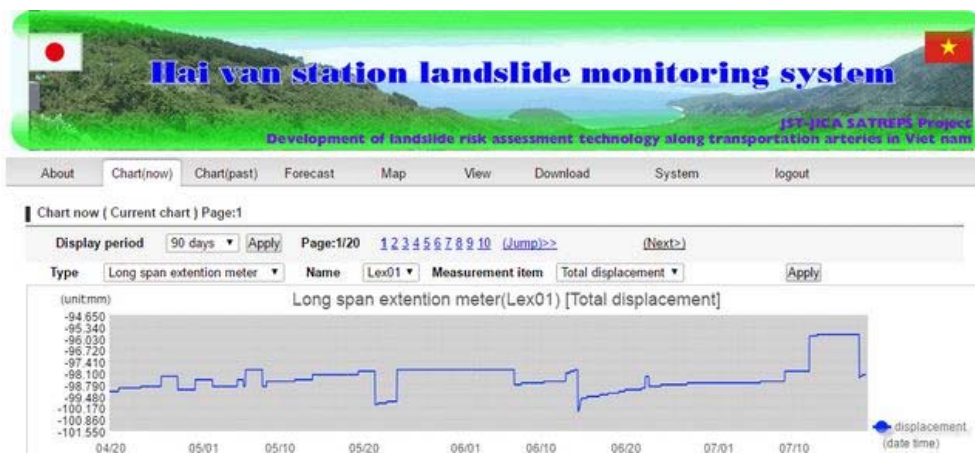
Fig. 7. Display of the data on web observation system (Asano et.al. 2016)

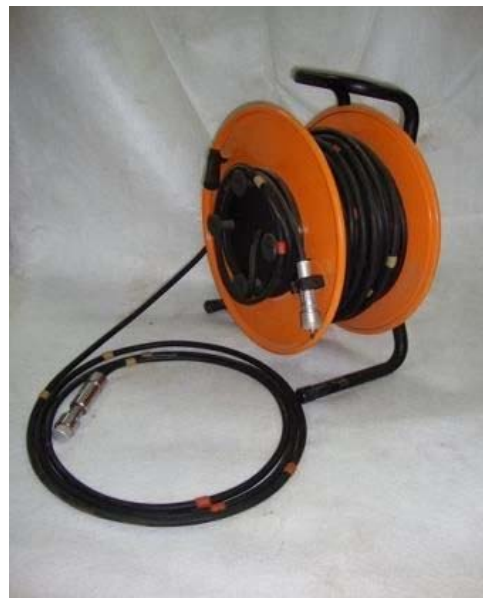
Interconnecting cable has to ensure uninterrupted signal and tenacity to hang the probe during measurement and used to test the depth of the probe tilt. Cable marked equally spaced points depending on the distance of two-wheels center measured (Figure 6).

Figure 6 – Interconnecting cable

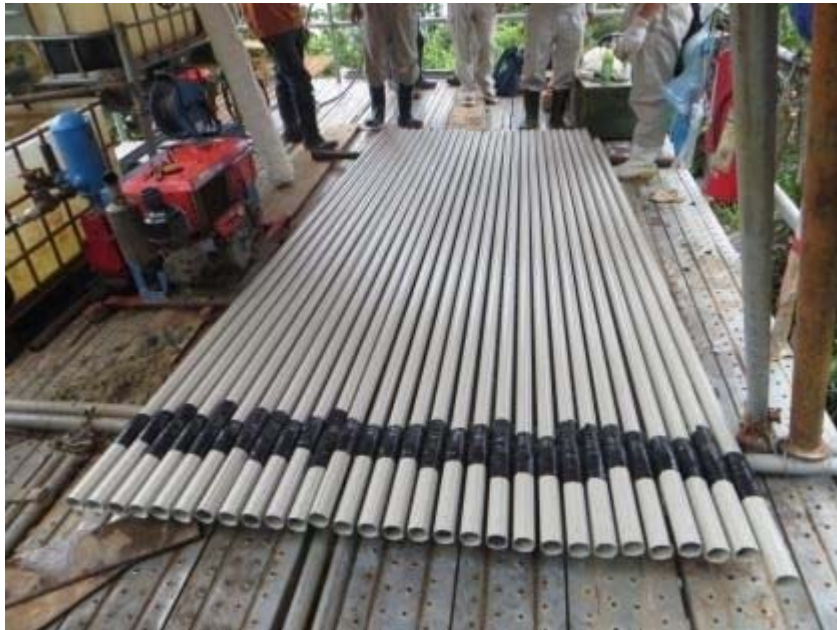
At this project Inclinometer casing made of aluminum, has round cross – section, suitable with probe of inclinometer. Inside the Inclinometer casing has four channel with vertical direction, and has event distance is 900mm to made the wheel of probe of inclinometer move closely to the wall of pipe. The length of Inclinometer casing portion is 3m (Figure 9). Inclinometer casing has no deformation of diameter when applied loading follow the depth.

Figure 9: Inclinometer casing

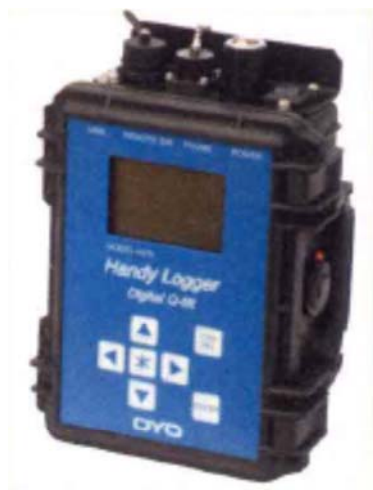
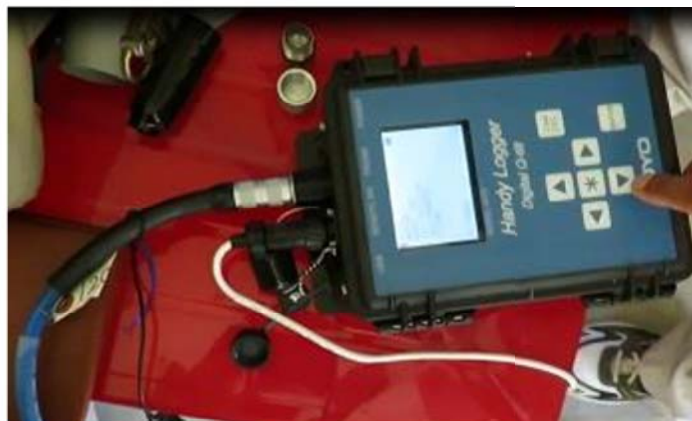
11.2.3 Logger

Remote Monitoring

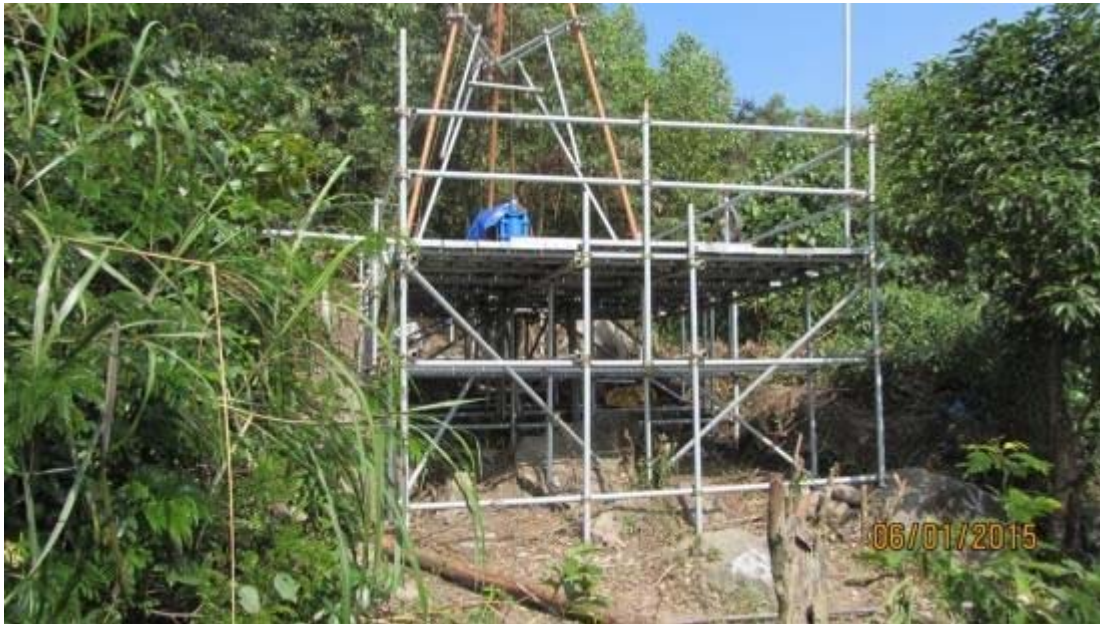
Due to complicated terrain at HaiVan so we need use drilling rig

Figure 15: rig system

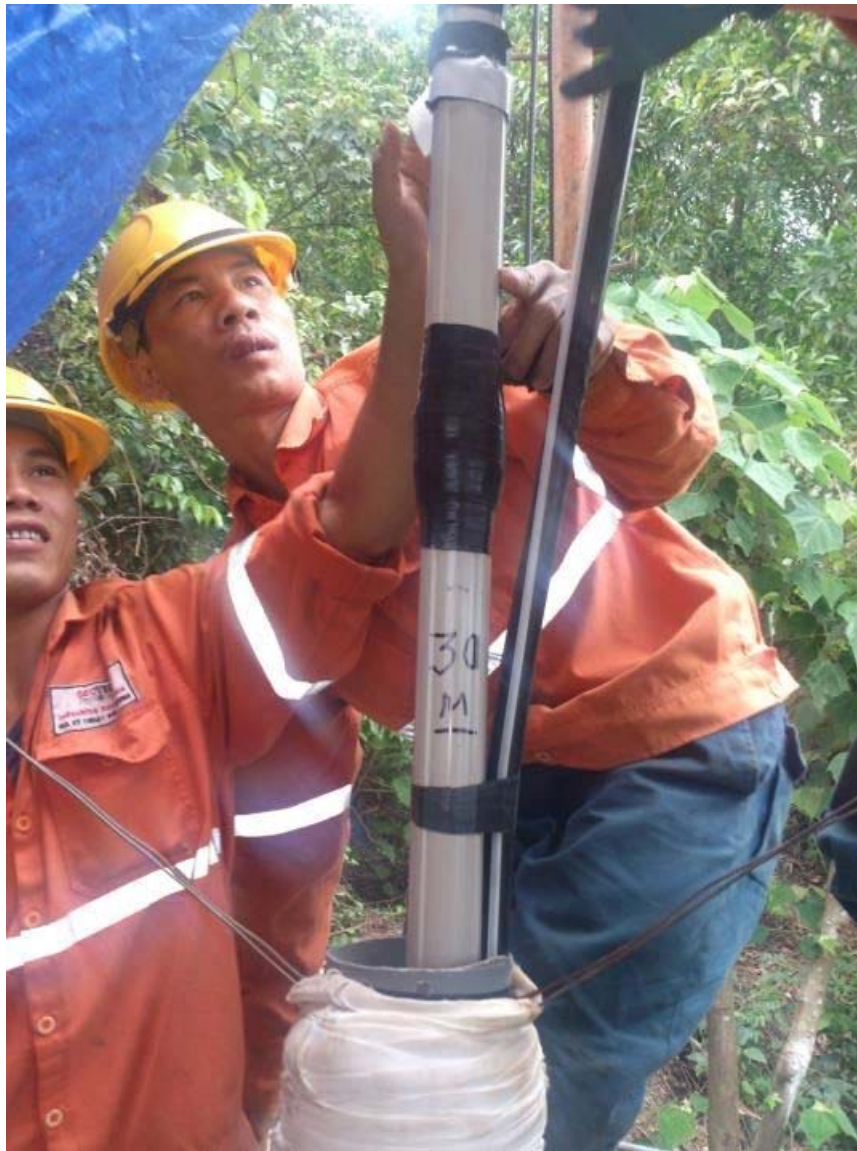
Lower the first pipe with attach seal cap at the bottom to under position of Inclinator casing , the first injection grout is attached to portion of the first Inclinator casing , the distance from injection grout pipe to the bottom of drill hole is 0.5m. Attach the bottom part of second pipe into the top of the first pipe, adjust channel of each portion tube in alignment. Joint between two pipe made by specific colloid and must ensure no have dirt's outside come in. If the depth more than 80m installs three injections, grout pipe with the distance between each other is 30 m approximately (See Figure 16).

Figure 16: Install inclinometer casing and insert tube to pump grout

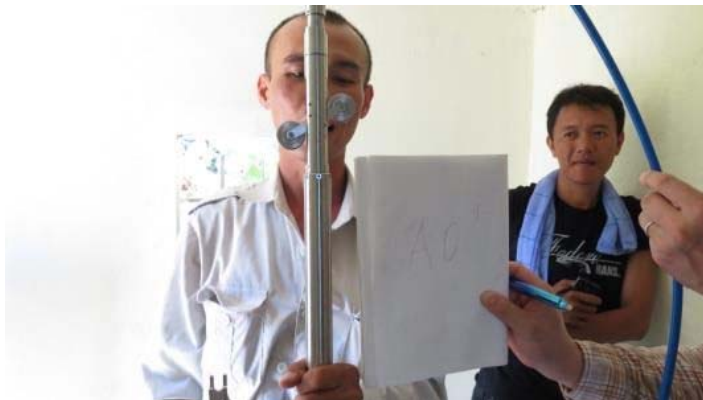
- Insert probe inclinometer in A_0 - A_{180} direction (wheel of probe insert in A_0 channel (See Figure 17). The probe goes down gradually to the bottom of Inclinometer casing . The probe keeps in inclinometer casing about 10 minutes balancing with the temperature with temperature in inclinometer casing . Taking measure by pull the probe and maintain the probe fix at the marked depth in cable signal, wait the reading stable , read and record data (depth, reading R) in the reading apparatus. Continue pull probe in specific distance an take the next reading (See Figure 18).

Figure 17: Insert probe inclinometer in A_0 - A_{180} direction

Lower end cap of the inclinometer automatically after connection (section 11.6.1) down inclinometer casing, the plane contain the wheel of the first probe into the groove A_0 - A_{180} of inclinometer casing. The wheel above (fixed wheel) in the groove A_0 or A^+ (see figure 17).

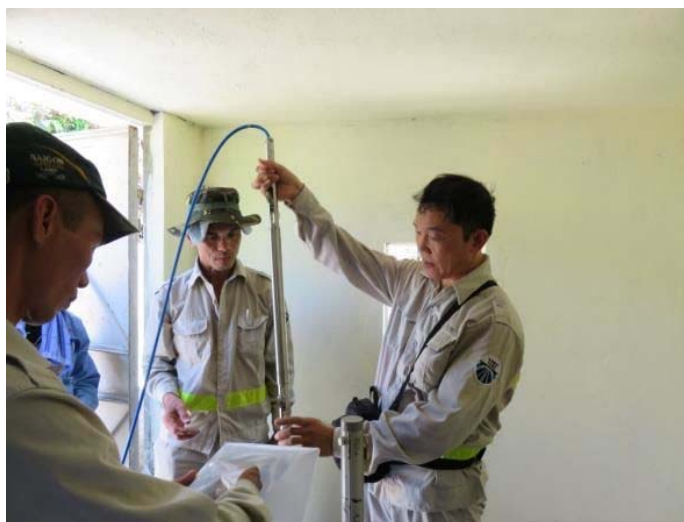
- Repeat this process until the probe reach to the top of Inclinometer casing . Pull the probe out of inclinometer casing and rotary 180° to take the wheel on the probe into channel A_{180} and lower the probe to the bottom of Inclinometer casing . Take to data at specific depth as the first time

Figure 18: Rotary 180° to teke the Wheel on the probe intro Channel A_{180}
