Development of Landslide Risk Assessment Technology along Transport Arteries in Vietnam

Proceedings of the Final SATREPS Workshop on Landslides

13 October 2016, Hanoi, Vietnam

Published by
Institute of Transport Science and Technology (ITST)
International Consortium on Landslides (ICL)

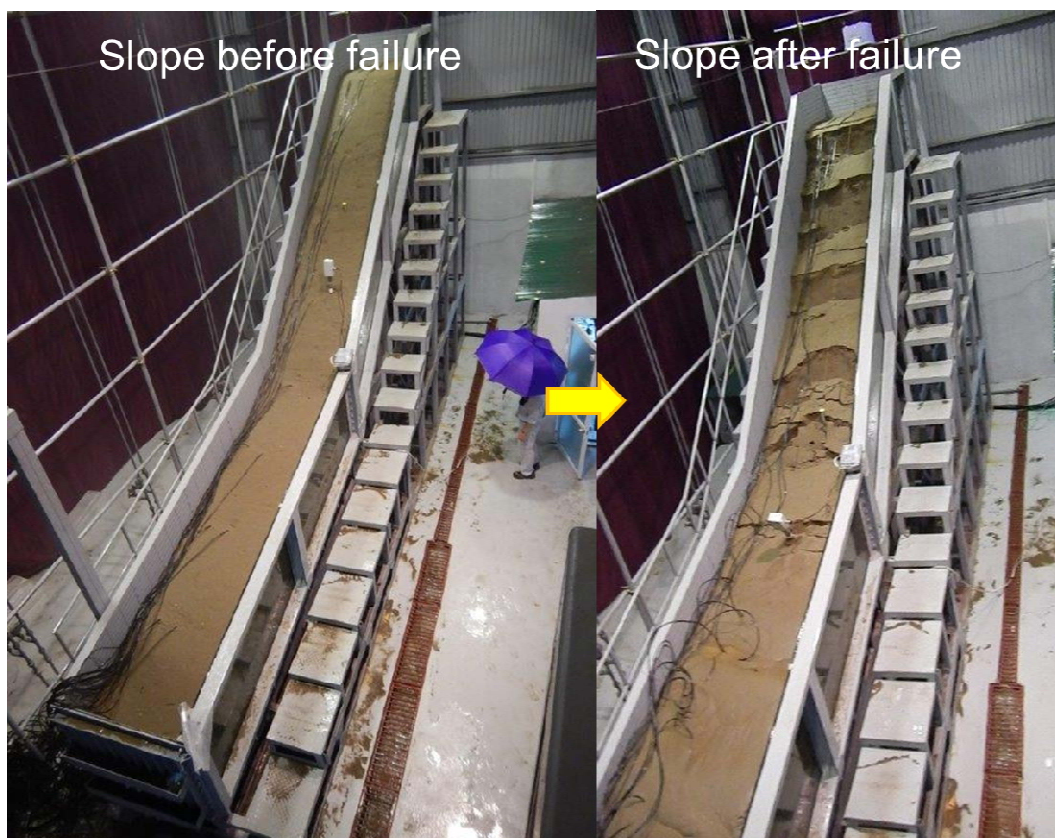
Fig. 4: Slope before failure (left side) and after failure (right side) on flume experiment in ITST
(Hirotaoka Ochiai et al., 2016)

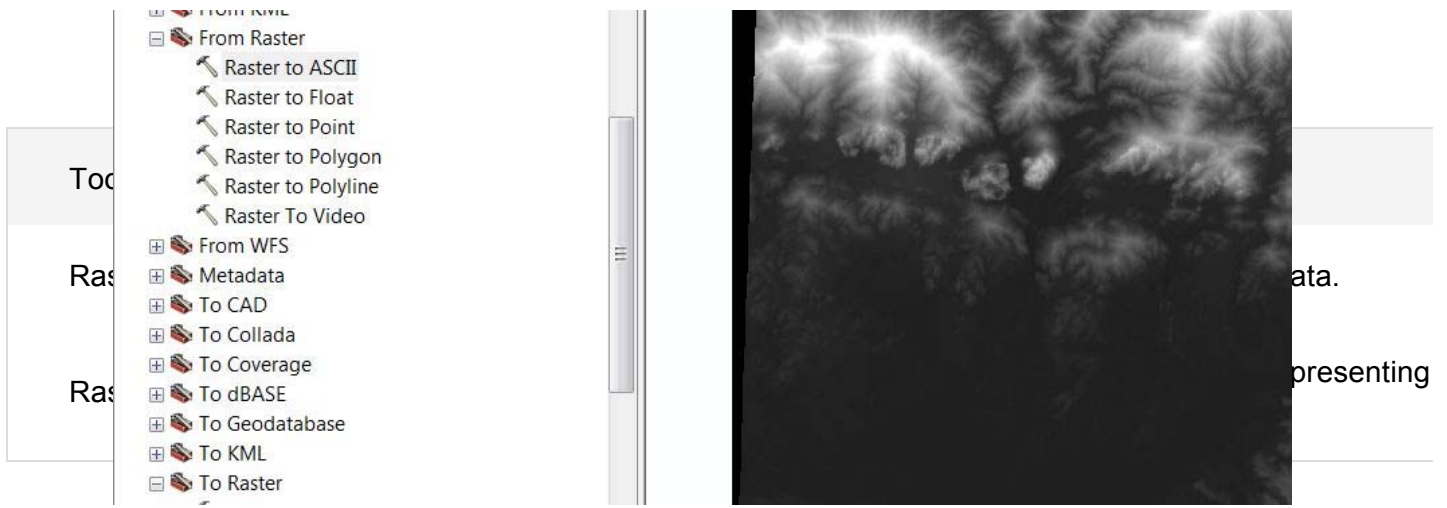
Fig. 9 Raster to ASCII

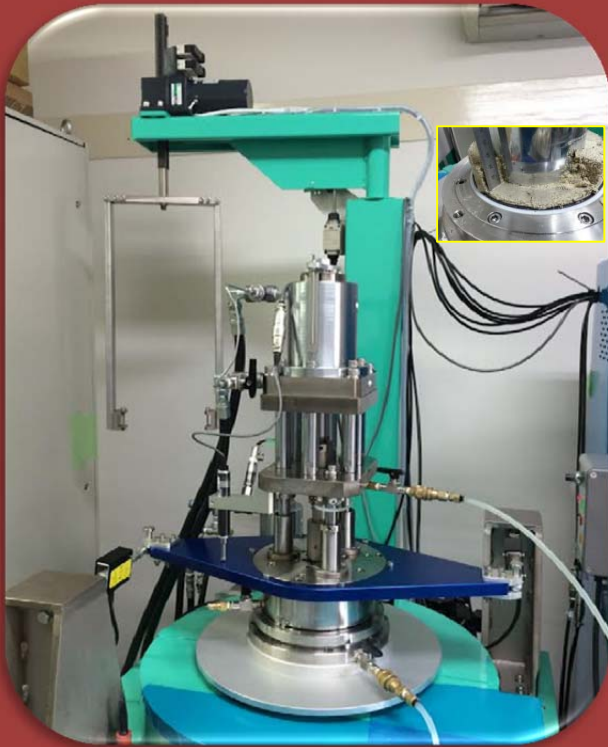
Ring-shear Apparatus

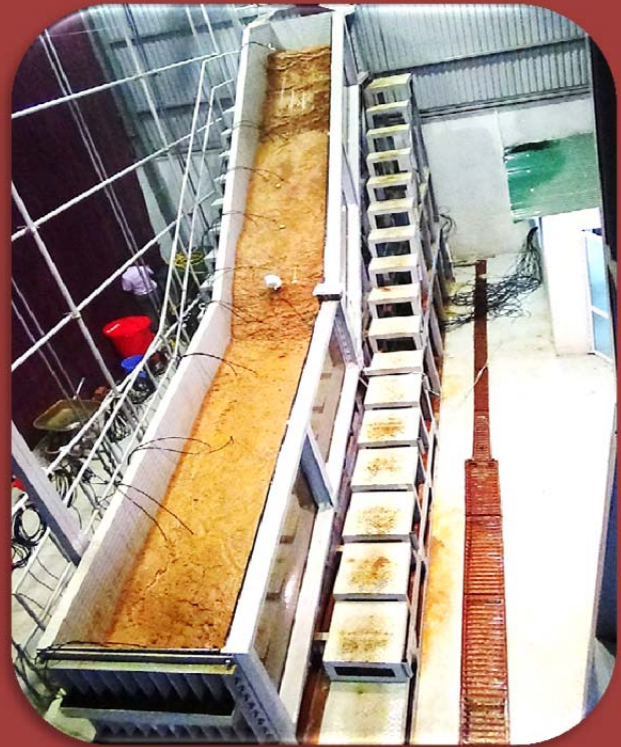
Landslide Flume
