2018 IPL SYMPOSIUM ON LANDSLIDES

03 December 2018
Kyoto University, Uji campus, Kyoto, Japan

Organized by
International Consortium on Landslides (ICL)

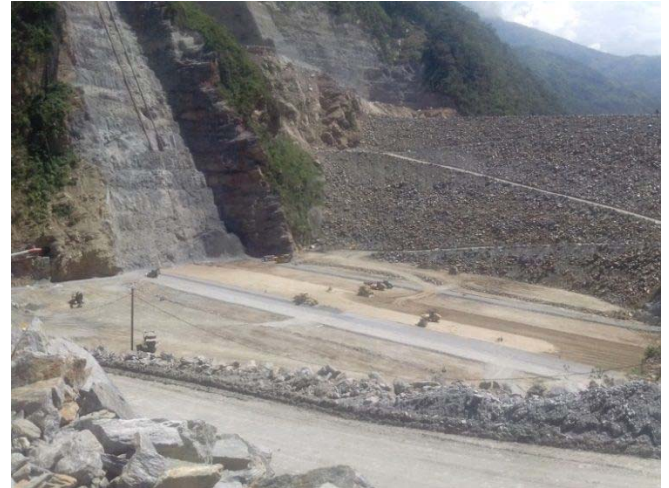
The significant magnitude of the project may be observed in the photograph of Fig. 4 that shows the dam during the construction process. Here the dump trucks serve as reference scale.

Figure 4. Photo of the dam construction process (Cortesy of R. Moreno).

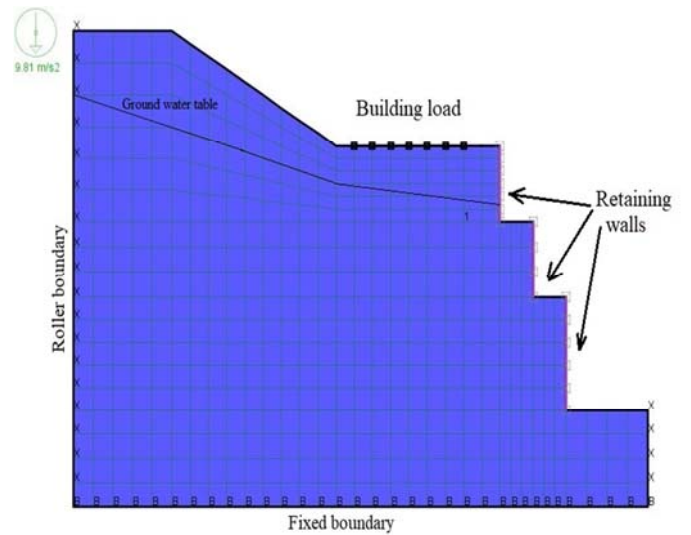
Properties of soil and reinforced concrete retaining wall are considered for the analysis as per authors earlier reported study (Chandrasekaran et al. 2013a). The geometry of the structure and boundary conditions adopted for the analysis are shown in fig. 12. The displacement of retaining wall is depicted in fig. 13. The displacement contours (fig. 14a) and shear strain increments (fig. 14b) show the slip surface which agrees with field observations.

Figure 12 Geometry of slope showing grid elements and boundary conditions

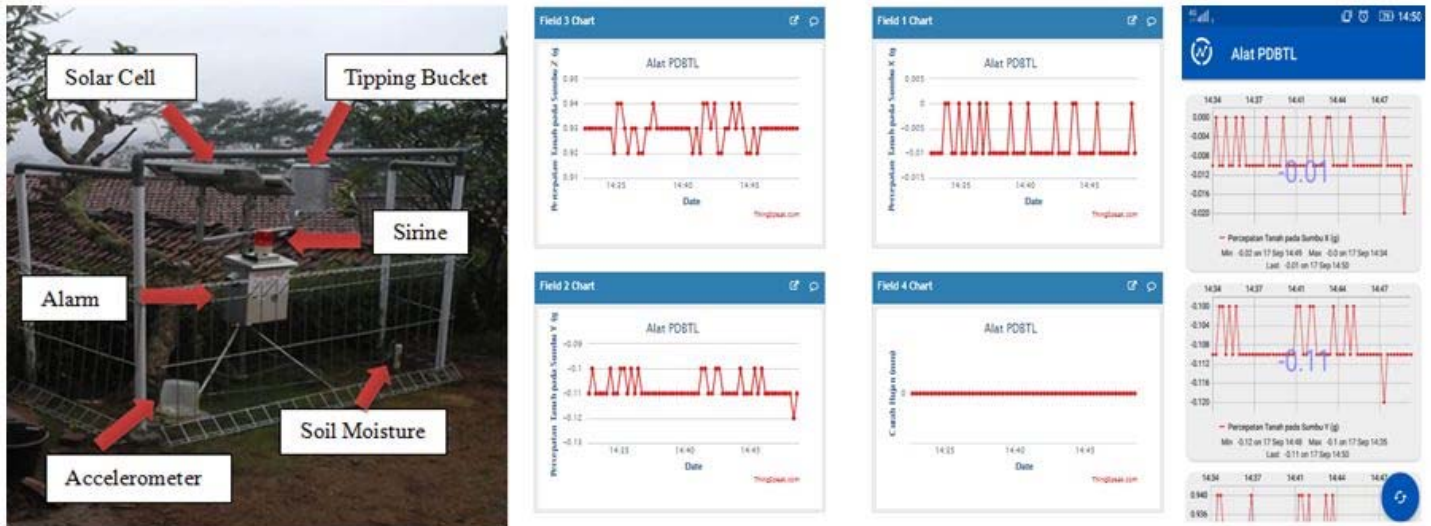
If the user accessing via smartphone can download the Thing View application on the Play Store then input the 539055 channel to view the graph in realtime. The following is the system view on websites and smartphones as in Fig. 13.

Figure 13 (a) Trial of EWS instruments in Sijeruk Village, Banjarnegara, (b) display of measured parameters on the website and (c) Smartphone

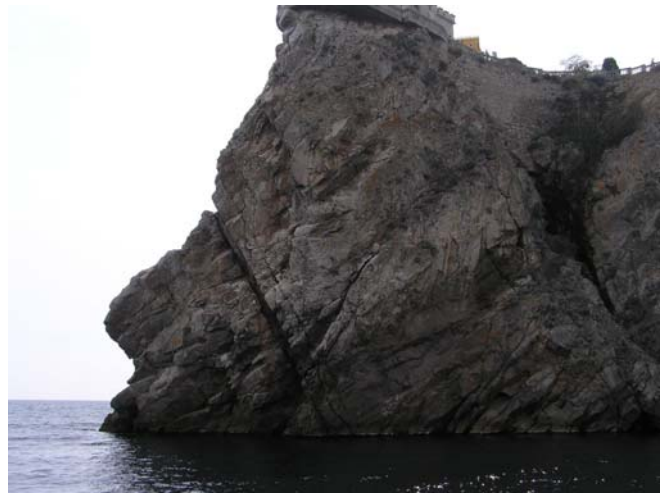
Figure 2 – The northern view. The huge crack separating some part of the rock from the main cliff part and a range of smaller cracks covering the whole Swallow's Nest castle base could be seen on the figure 2.

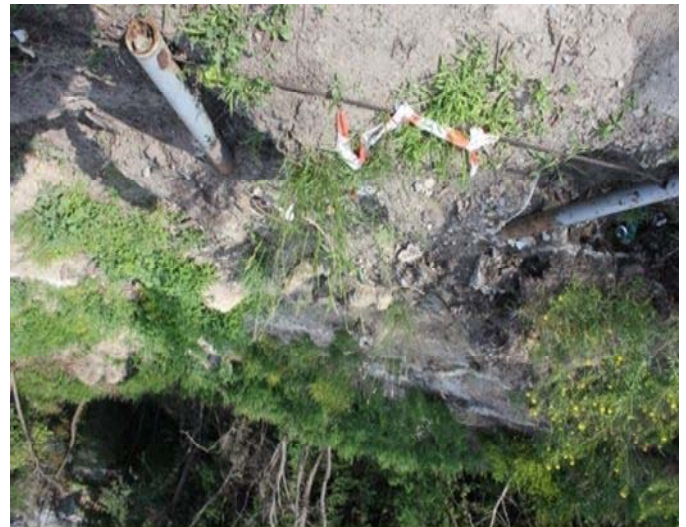
Figure 6 An example of the active development of landslide processes with active developments and erosion processes on the slope of the Church.

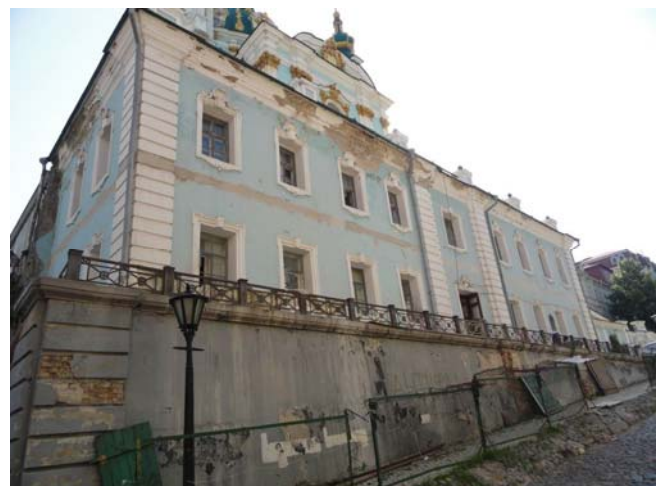
The visible superstructure of the church is based on a slightly wider in terms of underground two-storey foundation part of the church. The superstructure is joined to the underground foundation and is connected by a common entrance - a two-storey building, the covering of which is part of the church porch (see fig. 7).

Figure 7 General view of the church superstructure and the runway construction.

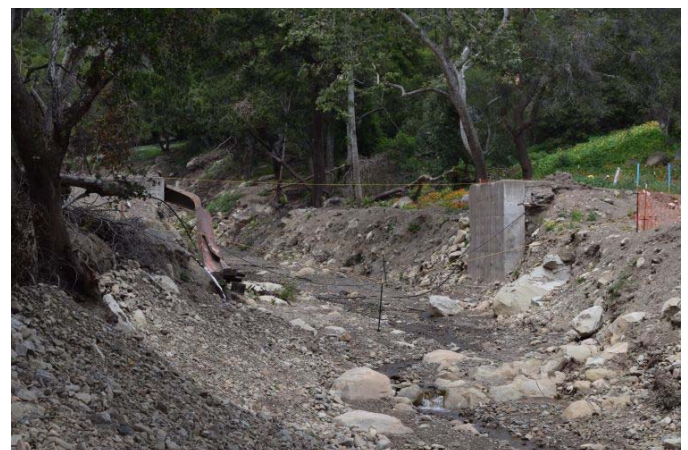
Figure 1 A bridge washed away due to waterway blockade.

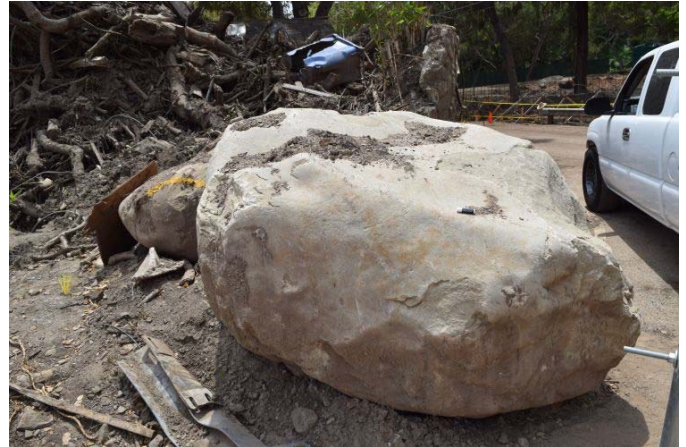
Figure 5 Size of boulders that slid down with debris mass.

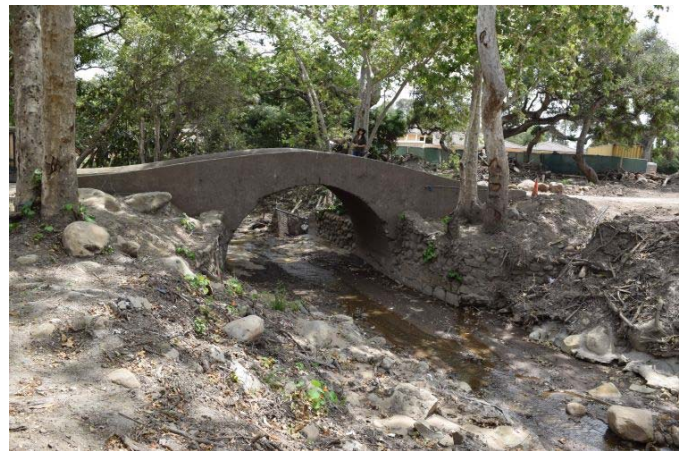
Figure 6 Culvert structure, right bank of which had debris flow diversion that caused a massive loss of properties.

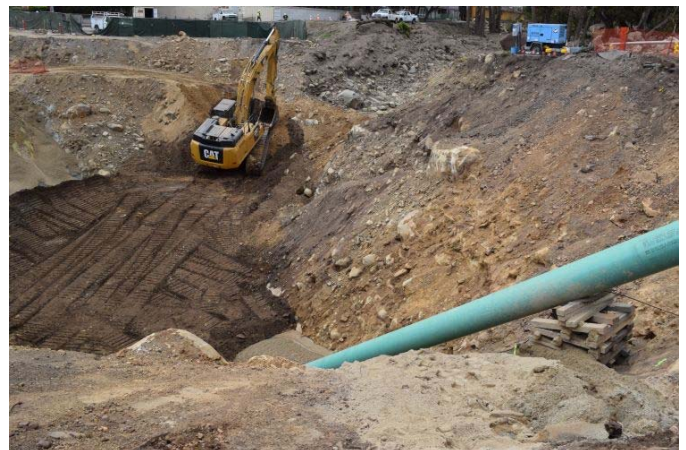
Figure 7 Gas pipeline that were damaged during the debris flow event and caught fire.
